**An assessment of Forestry Best Management Practices in North Carolina, 2018-2020**

**Prepared by:  
Water Resources Branch  
North Carolina Forest Service  
North Carolina Department of Agriculture and Consumer Services  
August 2022**

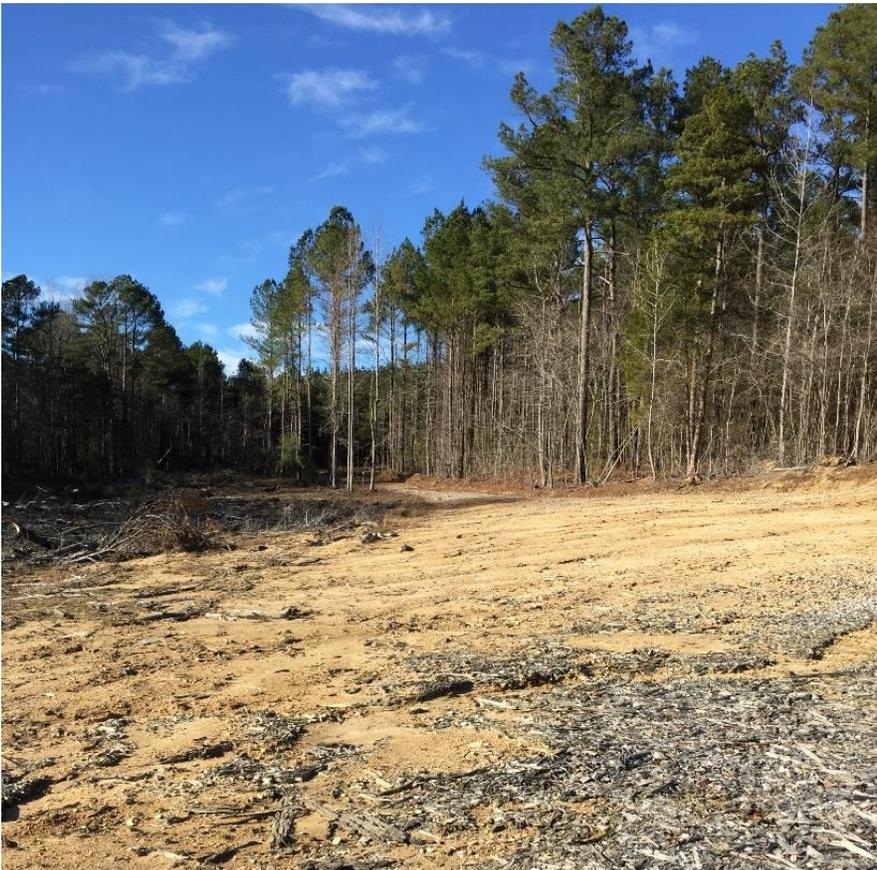
Photo 1. A broad area of bare soil on a surveyed site in the Piedmont ecoregion. Sediment displacement and transport is possible.

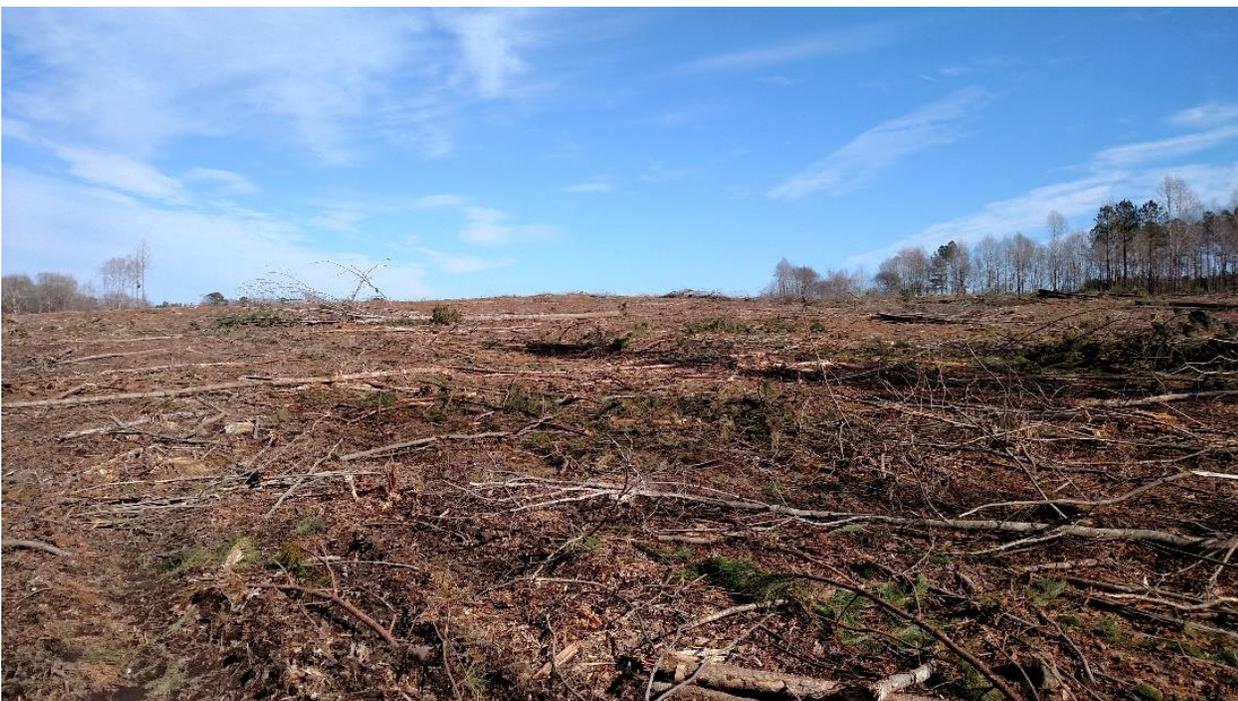
Photo 2. Ample slash and other materials are providing adequate groundcover to prevent erosion on this site in the Piedmont ecoregion.

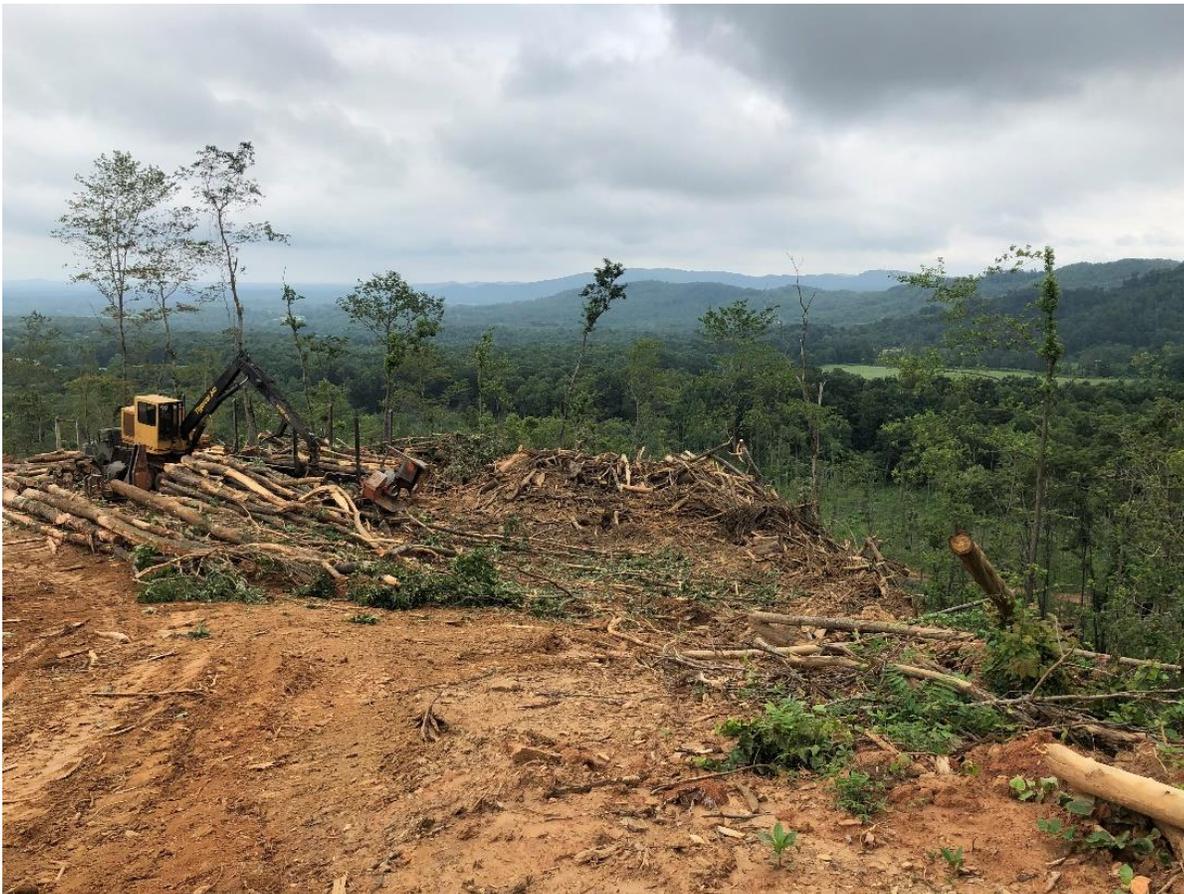
Photo 3. This logging deck in the Mountains ecoregion is on high ground away from the streamside management zones.

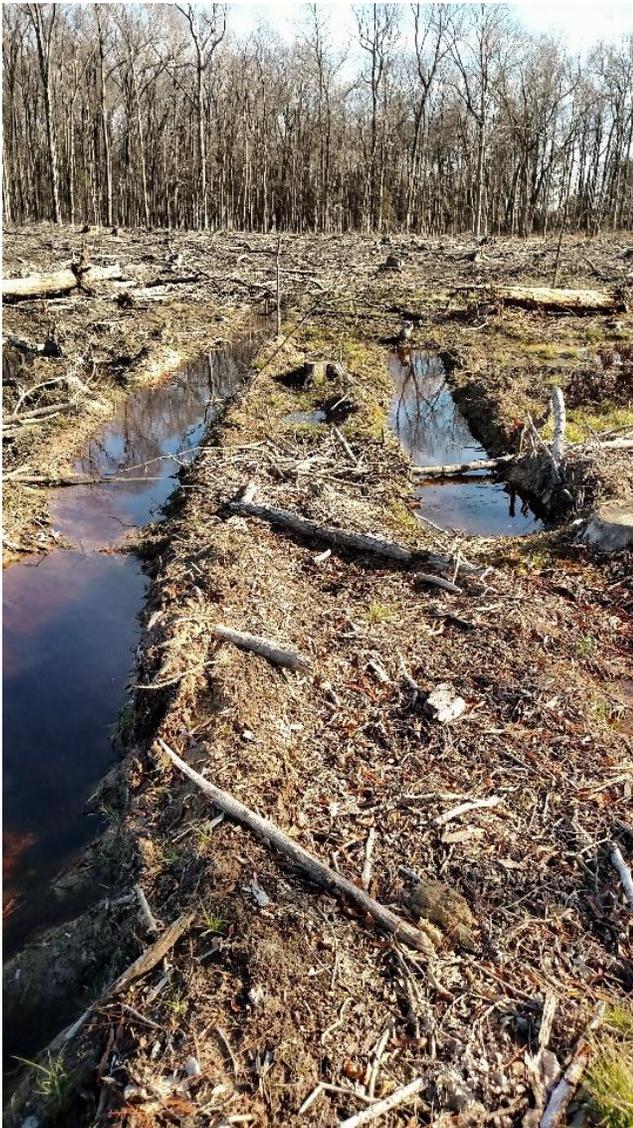
Photo 4. Undesirable soil rutting in a small area on a site in the Southeastern Plains caused by timber harvesting.

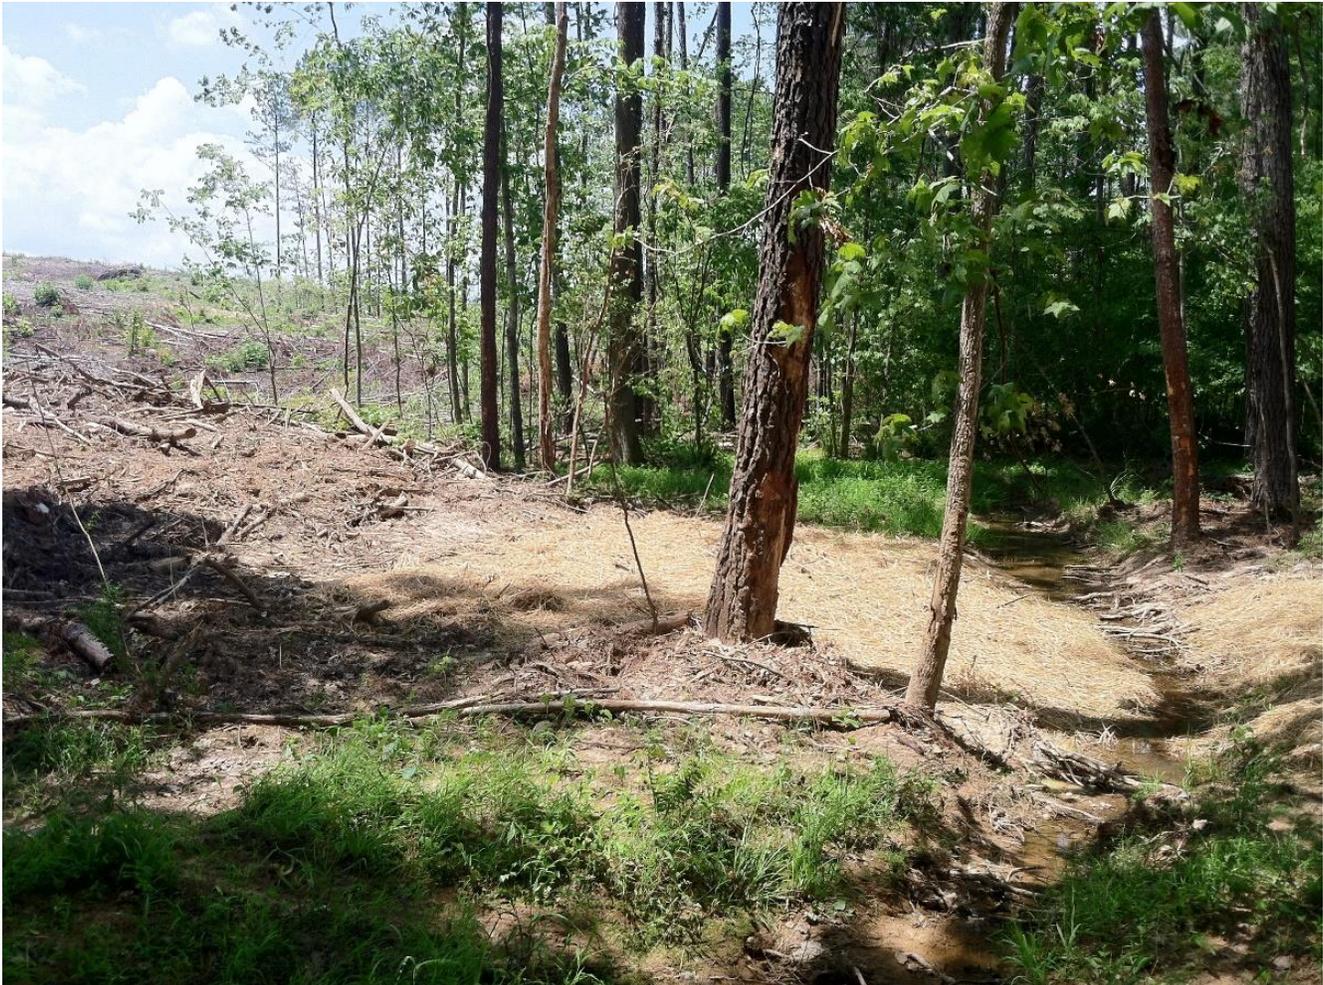
Photo 5. This stream crossing and approach way in the Piedmont ecoregion has been stabilized with straw and slash.

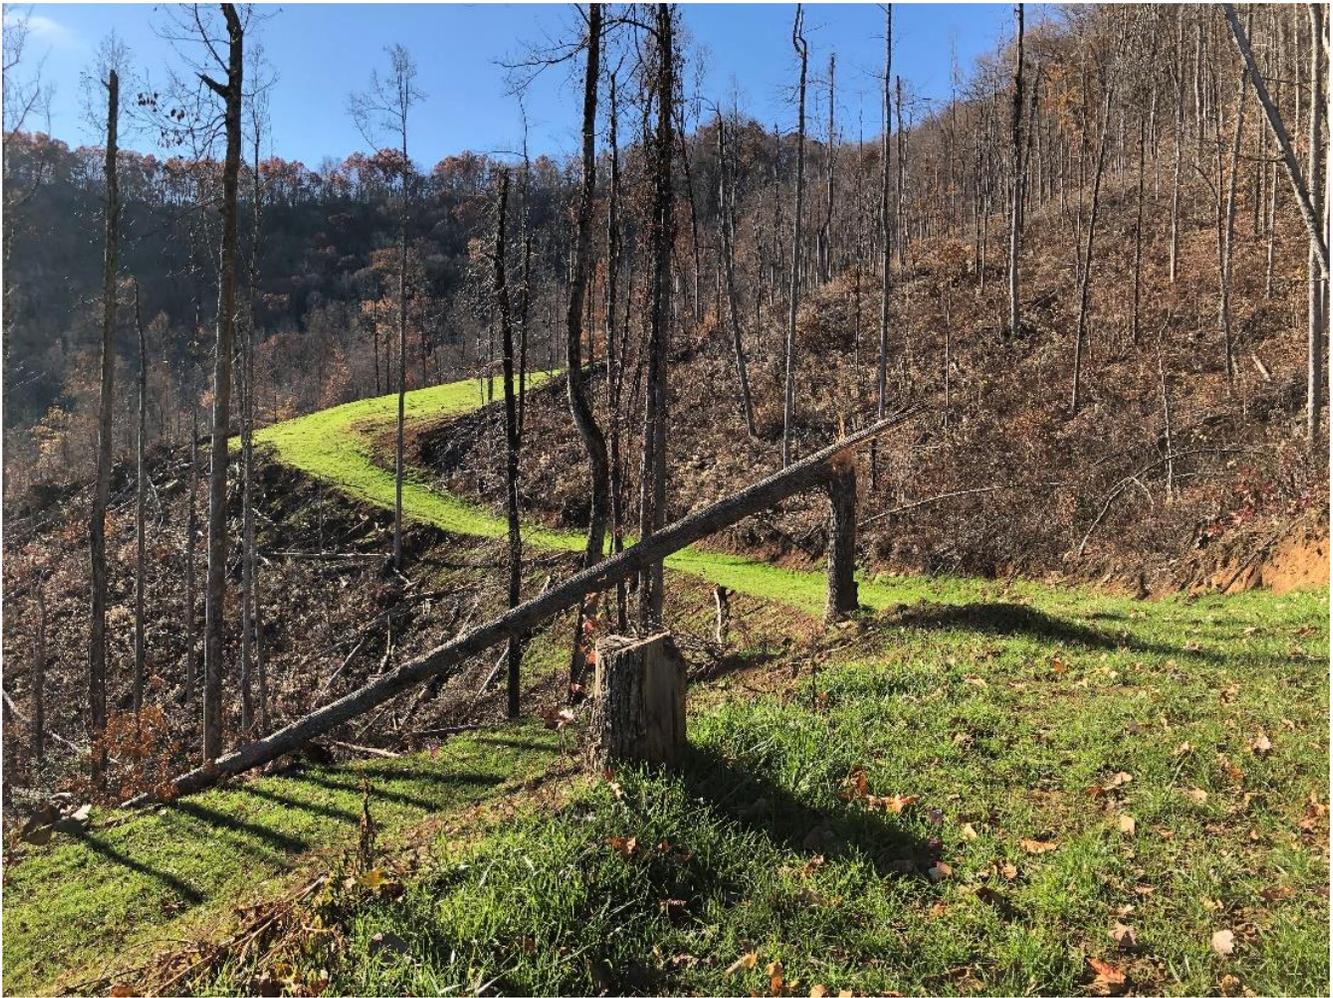
Photo 6. A skid trail in the Mountains ecoregion has been stabilized with grass.

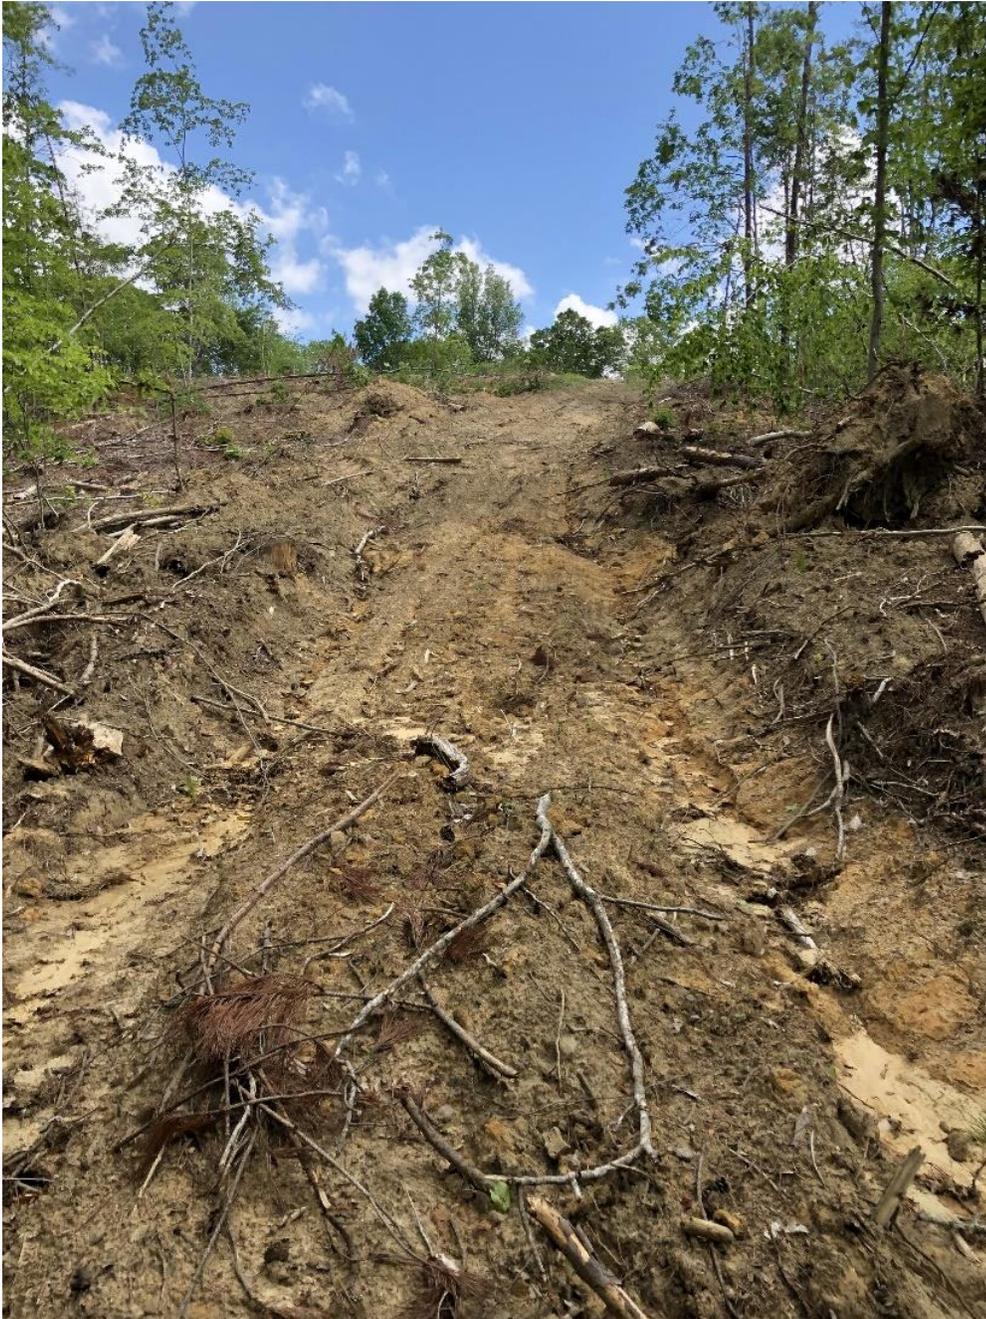
Photo 7. Erosion could be lessened along this long and steep sloping skid trail in the Mountain ecoregion by installing waterbars and turnouts to divert runoff in smaller increments onto more stable ground.

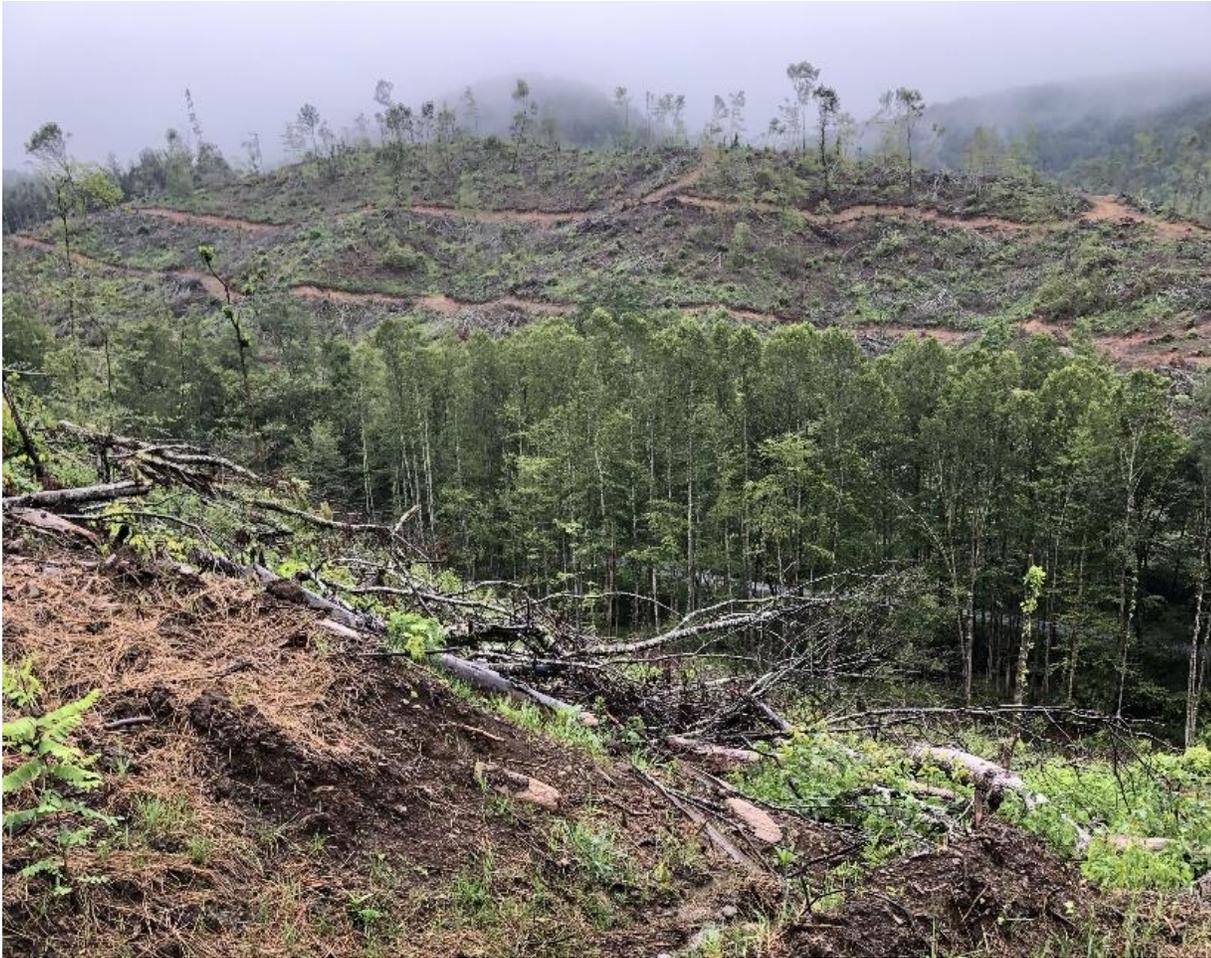
Photo 8. Skid trails in this tract in the Mountain ecoregions follows the contours and are located away from the streamside management zone, helping to minimize erosion and sedimentation potential.

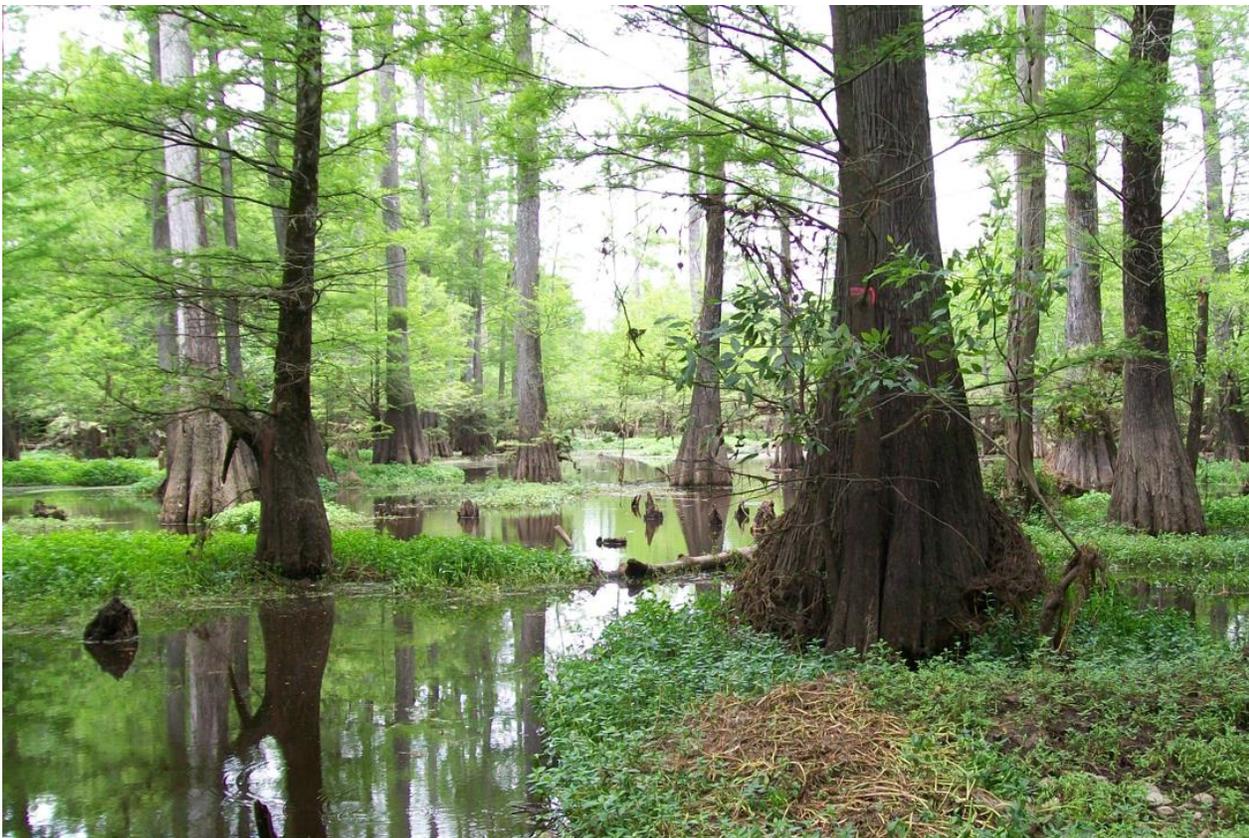
Photo 9. A forested wetland bordering a surveyed tract in the Mid-Atlantic Coastal Plain ecoregion.

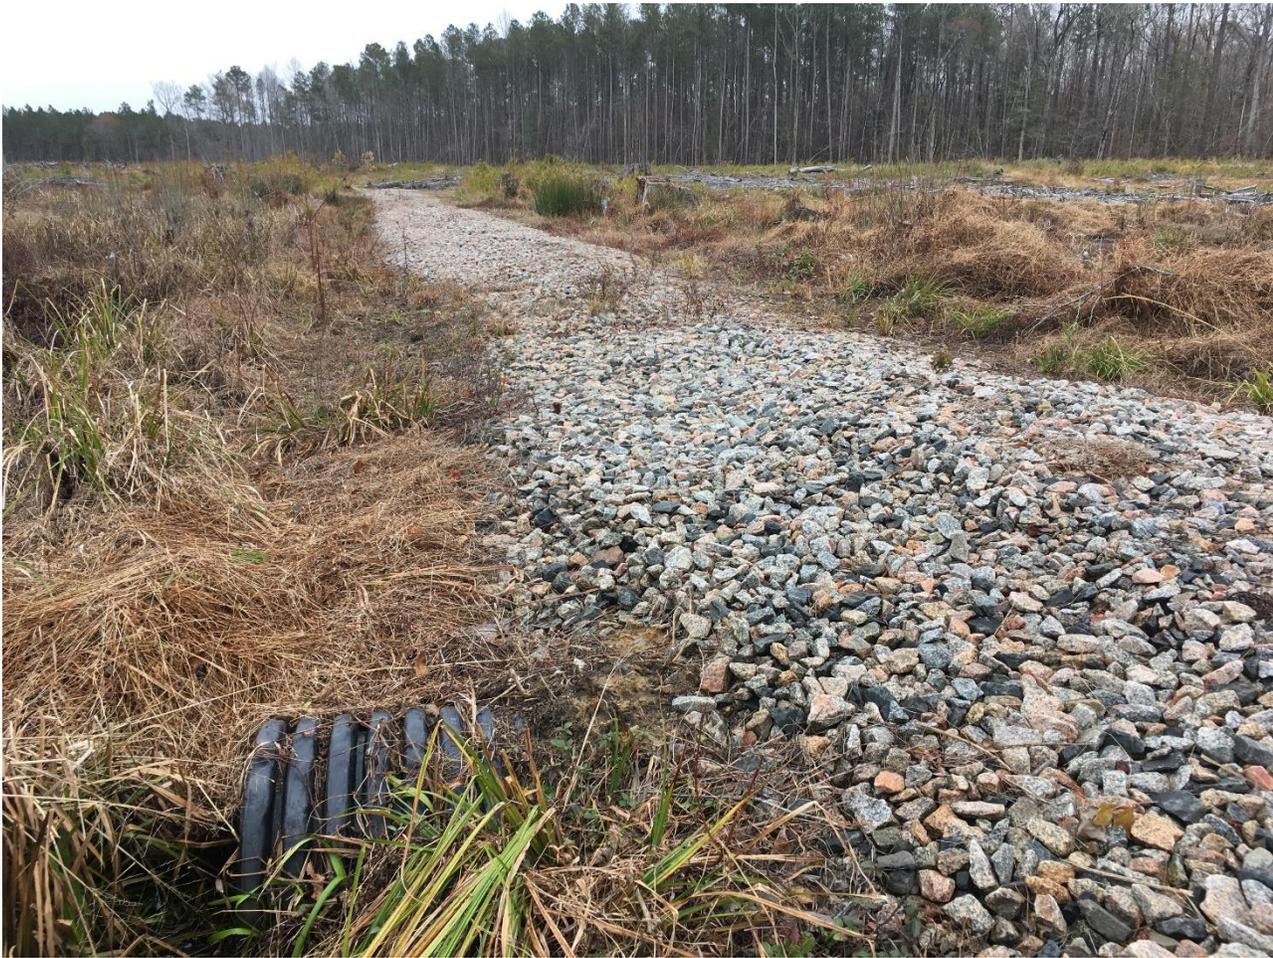
Photo 10. A well maintained minimum standard forest road on a site in the Coastal Plain ecoregion. A cross drain can be seen in the foreground allowing water to freely move through the area. Additionally, the stone surface helps to reduce erosion and rutting, while also allowing for more effective vehicle traffic in wet conditions.

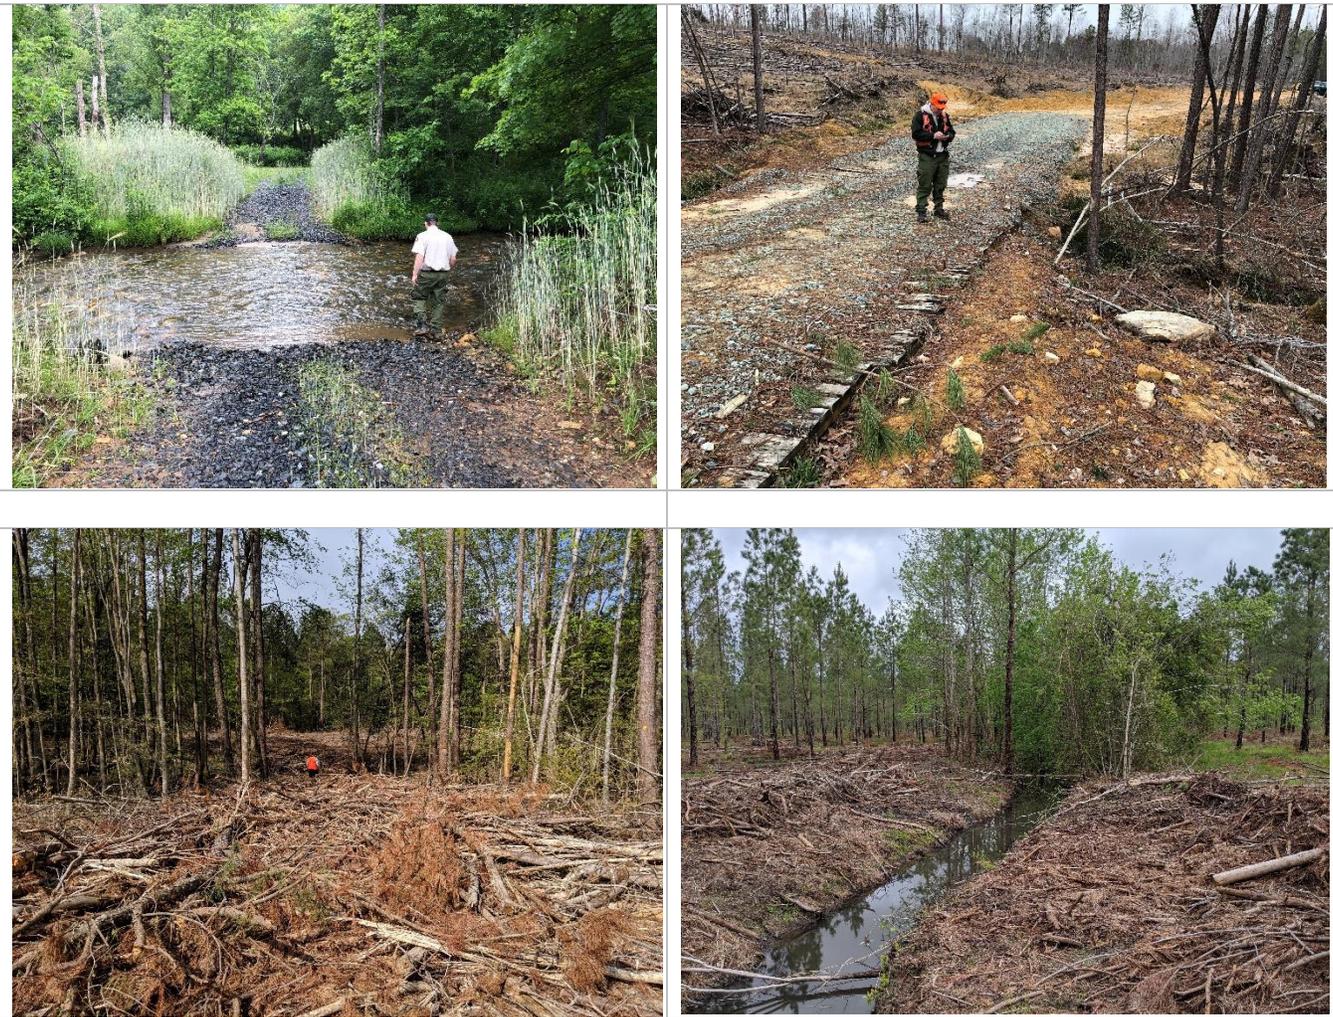
Photos 11-14. Good examples of stream crossings throughout the ecoregions. Top left (Photo 11): A permanent ford stream crossing on a Mountain ecoregion site used for haul trucks. Top right (Photo 12): A permanent culvert stream crossing on a Piedmont ecoregion site used for haul trucks. Road mats and gravel were applied for water quality protection, and the roadway turnouts reduce the amount of eroded sediment that needs to be captured by the streamside management zone. Bottom left (Photo 13): A closed bridgemat stream crossing on a site in the Southeastern Plains ecoregion with ample slash along both approach ways. Bottom right (Photo 14): A closed bridgemat stream crossing in the MACP ecoregion with piled slash more than 10 feet from the waterway and enough ground cover to minimize erosion. Also note the waterway is free from excessive logging debris.

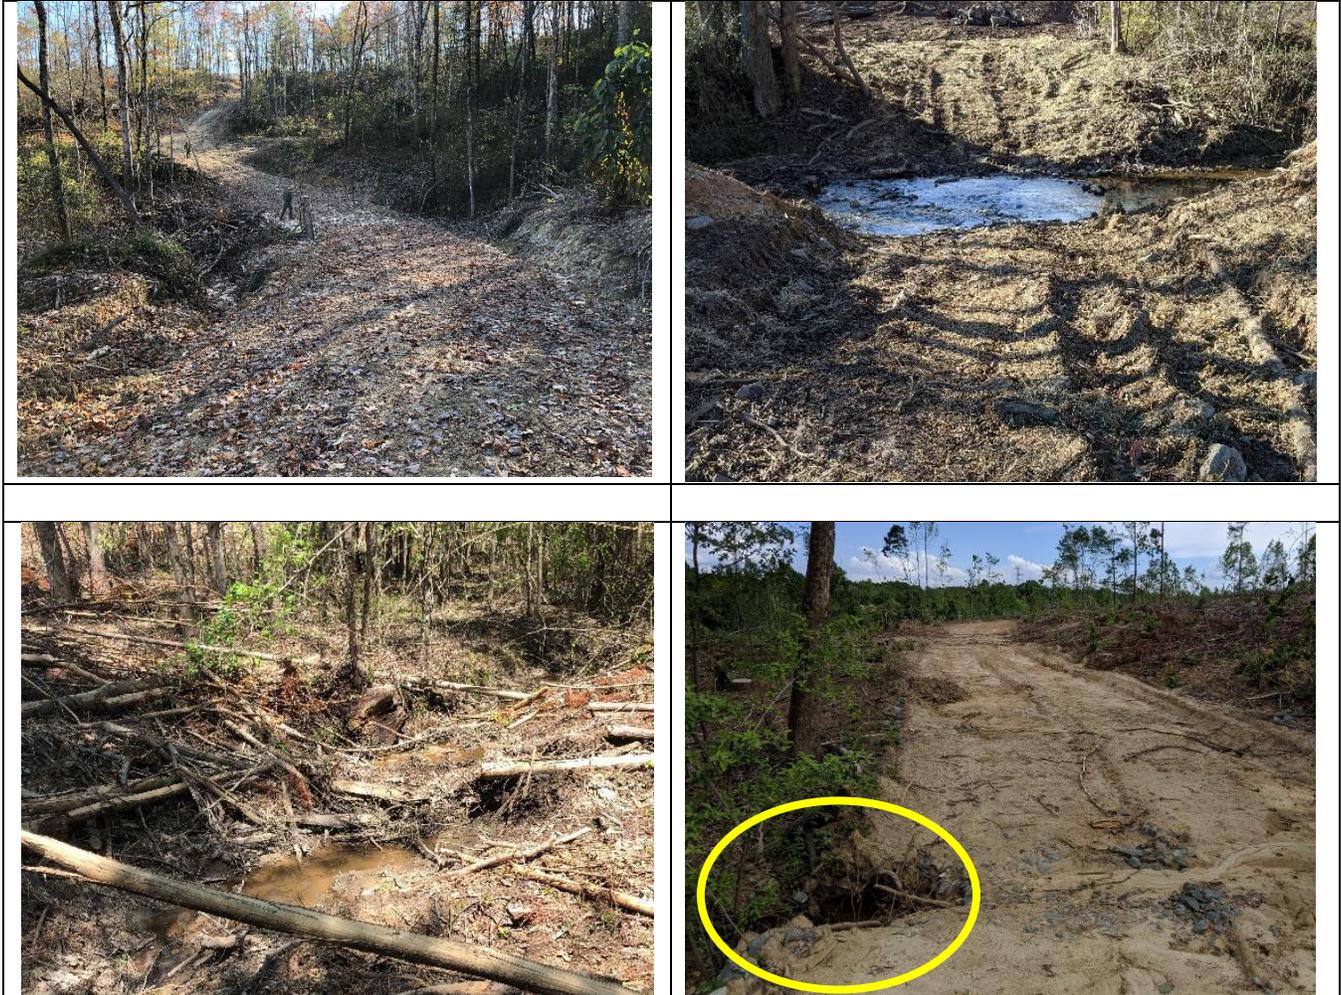
Photos 15-18. Examples of poor stream crossings observed during the survey. Top left (Photo 15): A permanent culvert stream crossing on a Mountain ecoregion site with ditchline turnouts feeding directly into the stream channel. Top right (Photo 16): An incised legacy road stream crossing on a Piedmont ecoregion site that’s been reused and in need of additional stabilization. Ruts leading into the waterway pose a water quality sedimentation risk. Bottom left (Photo 17): A closed bridgemat stream crossing on a Southeastern Plains tract with logging slash left within the stream channel. Bottom right (Photo 18): The end wall of this MACP culvert (circled) failed and needs repair. Runoff should be better controlled along the road as well.

- Stabilize approach ways using appropriate means (slash, laps, rock, etc.).
- Rehabilitate crossing area as soon as possible.
- Protect the inlet/outlet of the culvert/fill material with suitable stabilization measures.

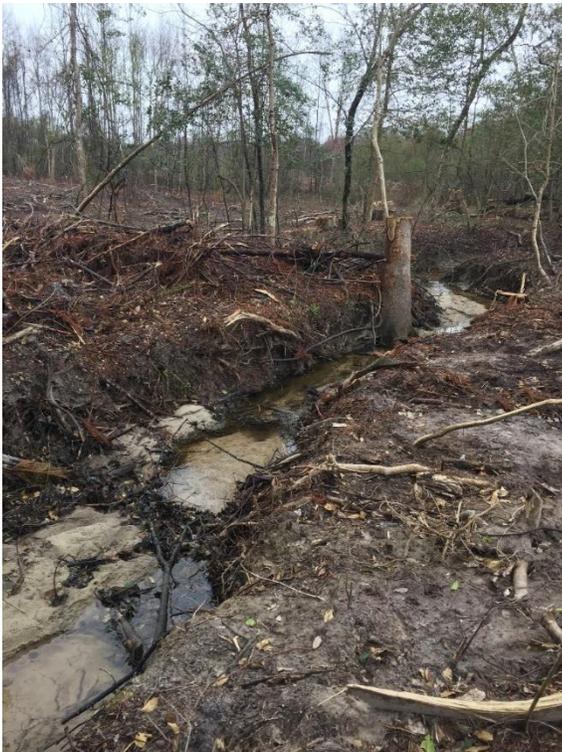
Photo 19. In this example of an improperly implemented SMZ, a significant number of trees have been harvested all the way up to the stream banks, resulting in increased sunlight exposure to the stream. Groundcover is lacking in portions of the SMZ, reducing its function in preventing accelerated erosion. Sediment that appears to be freshly deposited can be seen in the channel.

- Minimize disturbance to the soil and groundcover within the ephemeral stream area.
- Maintain approximately half of the preharvest vegetative canopy cover within the SMZ.
- Avoid roads, skid trails, decks and portable sawmills inside the SMZ.

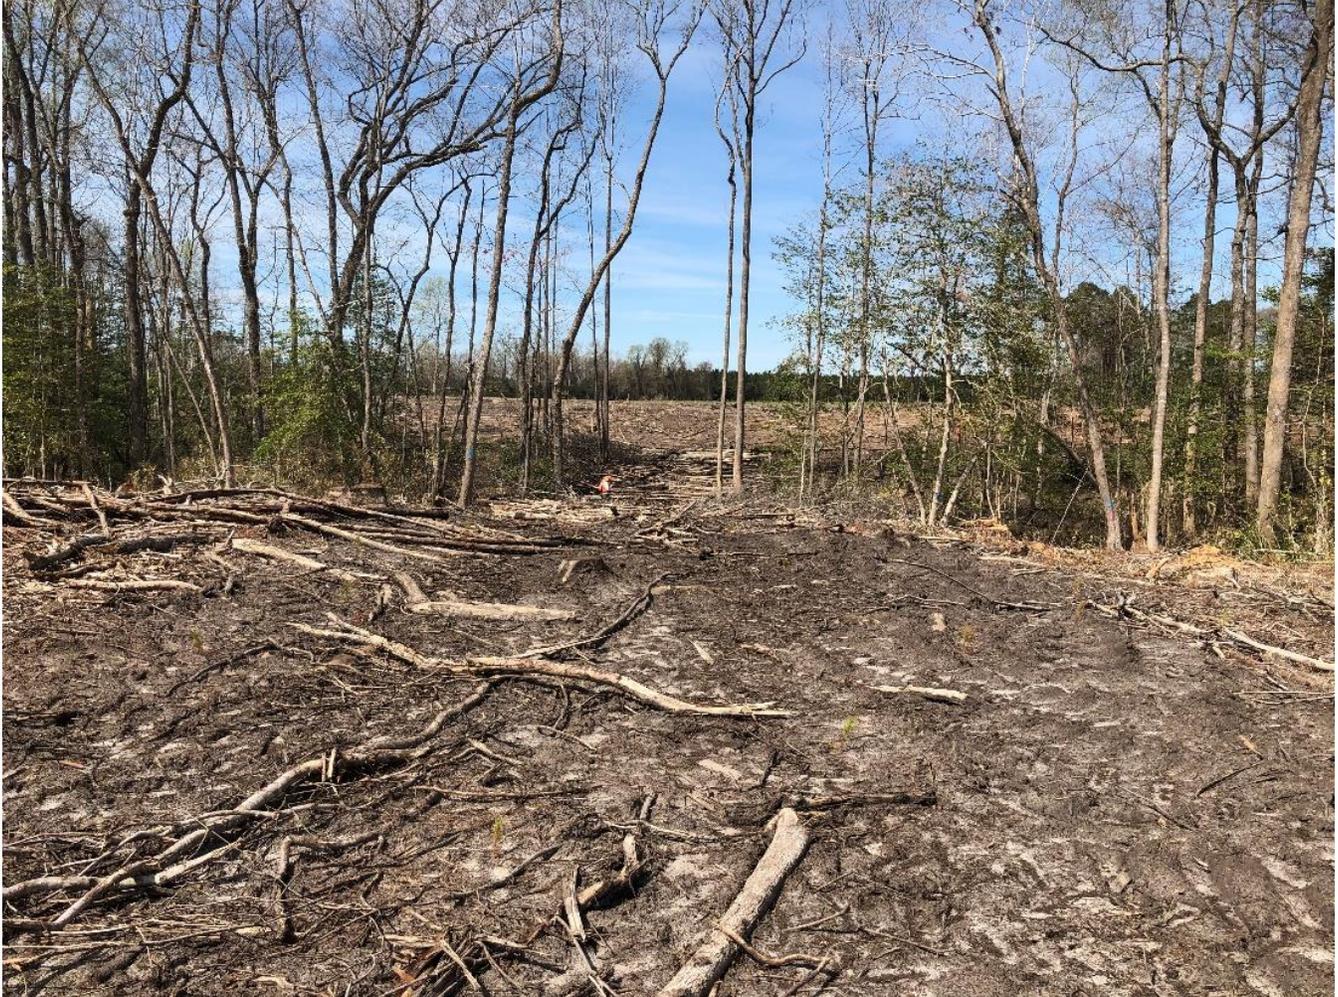
Photo 20. This is a good example of a SMZ. It was marked with flagging and maintained during harvest.

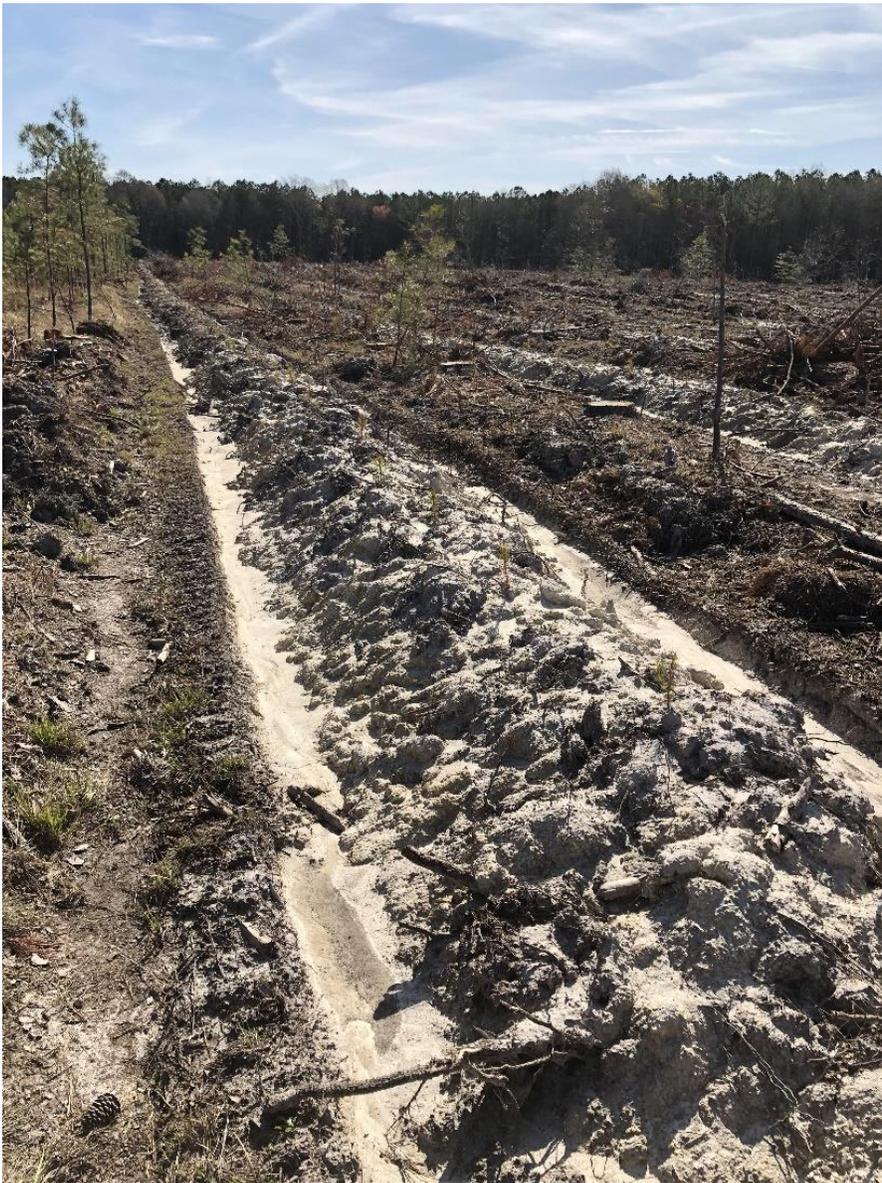
Photo 21. Bedding was used on this site to keep seedlings from being inundated with water. However, the soil appears to have mounded when wet, creating less than ideal soil structure for seedling growth.
