Stream Restoration Post-Implementation Annual Monitoring Report

Year 5: 2016

Project #10-0493:

“DuPont State Recreational Forest Lake Julia Outfall Stream
Restoration”

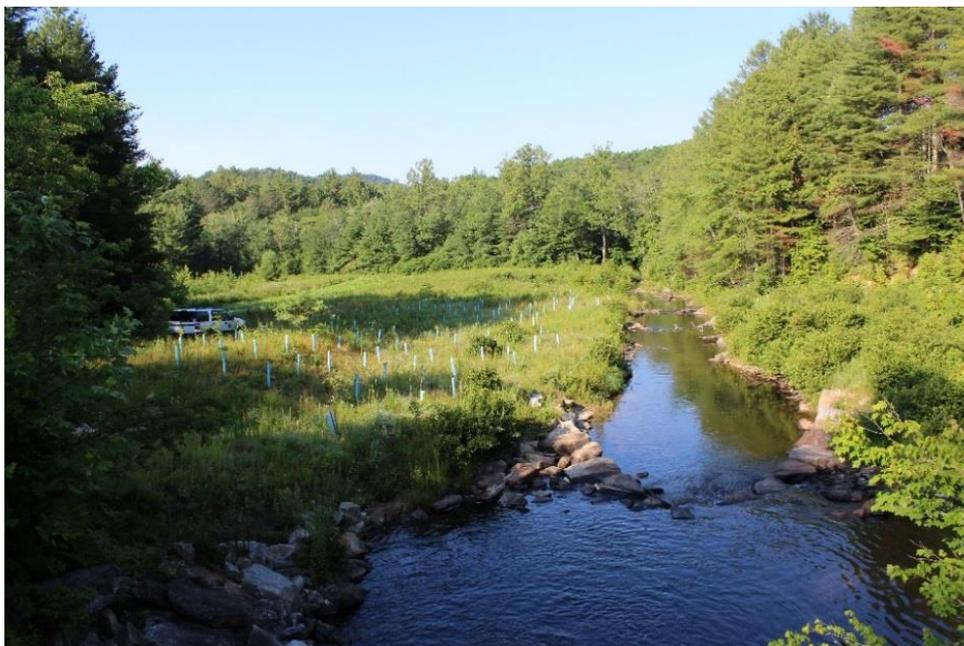
Photo June 2016. View looking downstream from the bridge.

Supplemental live stakes, installed along streambank edges by NCFS staff in May 2015, and other volunteer vegetation are exceedingly prolific throughout the restoration site (see photo above). Several locations along the stream bank had vegetation tall enough to begin shading parts of the stream. Exceptional growth of the transplanted alders on the right streambank (former stream channel location) were noted during the June 2016 site visit. Additionally, volunteer trees above the forest access road bridge (up-stream of the restored site) were noticeably taller than the previous year. This vegetation may reduce solar inputs to waters spilling over the reservoir's outflow weir and moving downstream.

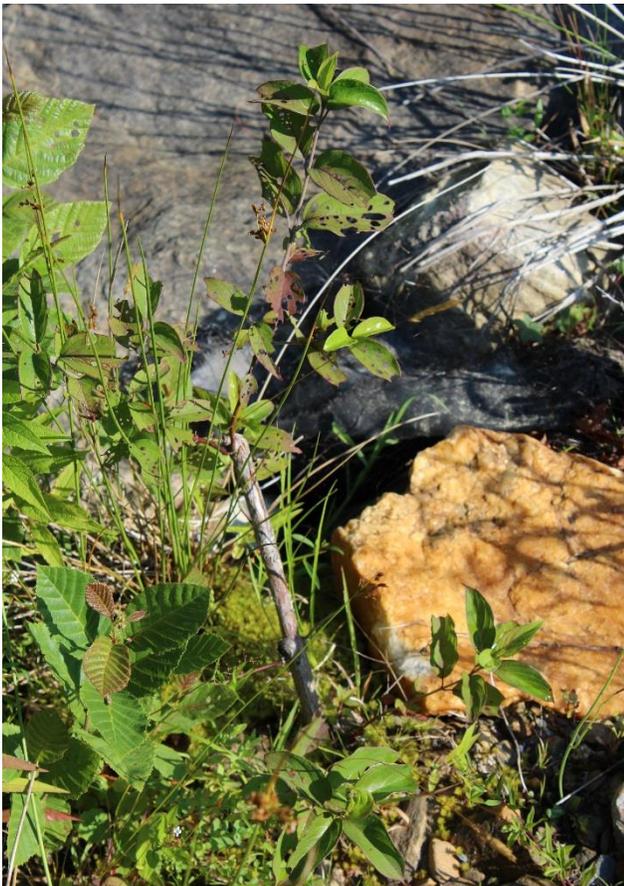
Example of established live stake established 2 year ago along with other competing vegetation on the streambank edge (left) and oak tree seedling and competing vegetation on the restoration site (right), June 2016.

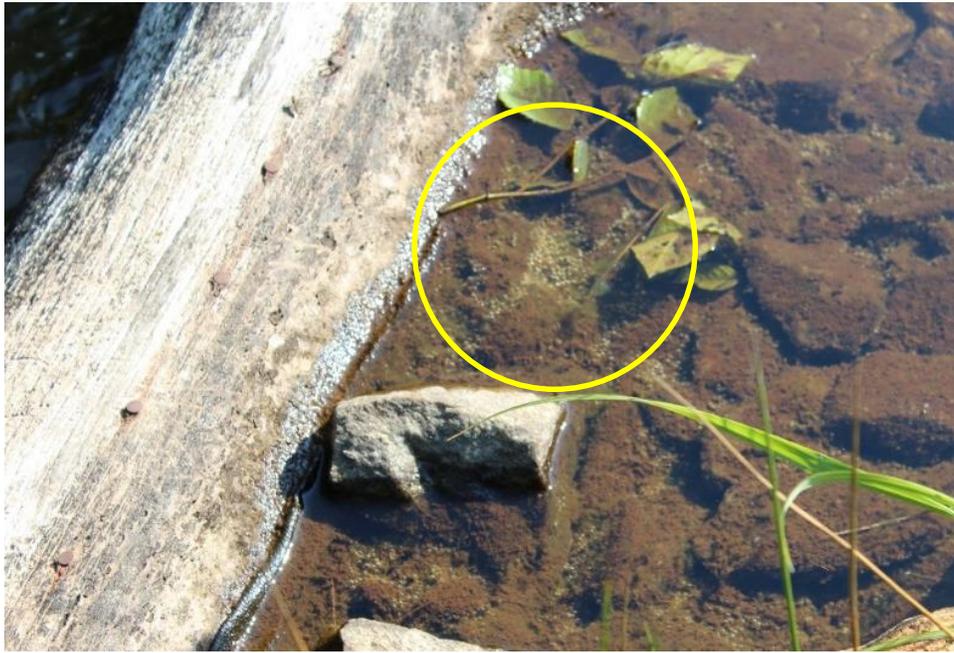
Amphibian eggs between a log vane and streambank.

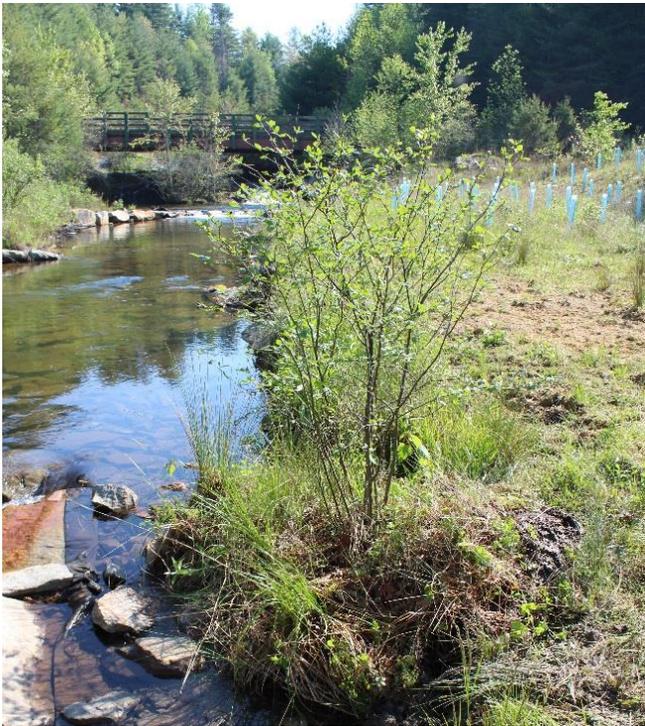
May 2015, immediately after transplanting of an alder shrub and rootball on left-bank.

Minor bank repair work was conducted in May 2015 at a location approximately mid-way down on the left bank of the restored reach. A nearby alder shrub was transplanted from the upland area, into a washed-out spot of the streambank to add stability. One year later, the transplant is thriving and providing bank stability.

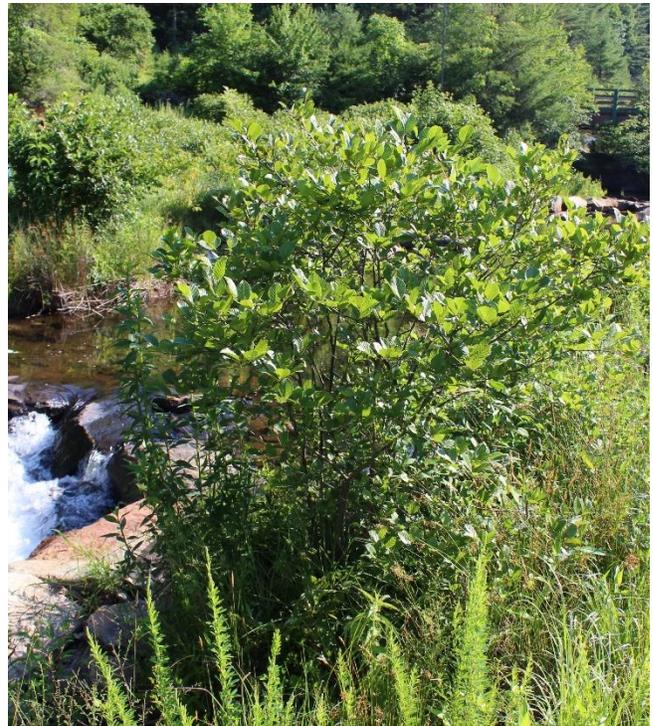
June 2016, one year after transplanting an alder shrub and rootball on left-bank.

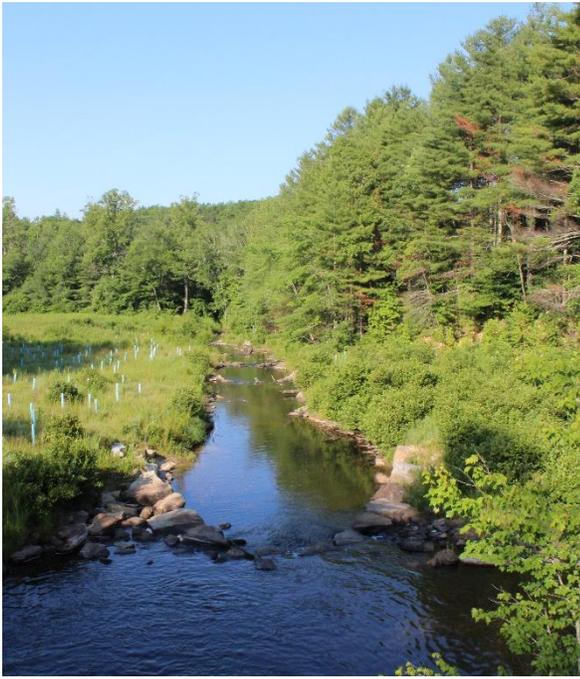
June 2016

The right-side of the stream (where the stream was moved from) was extensively covered by alder in June 2016. While the exposed legacy embankment on the hillside remains intact, it is mostly hidden by the vegetative growth (see right side of stream in the picture to the left). Some large eastern white pine (*Pinus strobus*) were showing signs of die-back and mortality, likely due to damaged root systems caused by continued exposure to the vertical soil embankment. These trees will be monitored by the DuPont State Recreational Forest staff and felled if deemed necessary. Overall, the stream channel design (plunge pools, log and rock vanes, and brush toe materials) is intact and functioning appropriately.

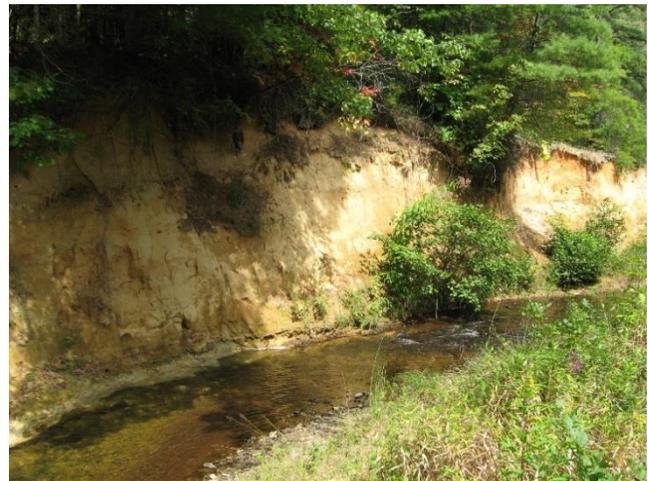
Stream channel near the forest access road bridge in May 2009 (left). Soil loss was occurring from the exposed vertical soil embankment on the right stream bank (legacy channel) in Sept. 2009 (right).
