BMP Request

Wetland Filters for Drainage Systems (Constructed Wetland)

Riparian Herbaceous Cover (Buffer) for Drainage Systems

Management Alternatives to Enhance Water Quality and Ecological Function of Channelized Streams and Drainage Canals

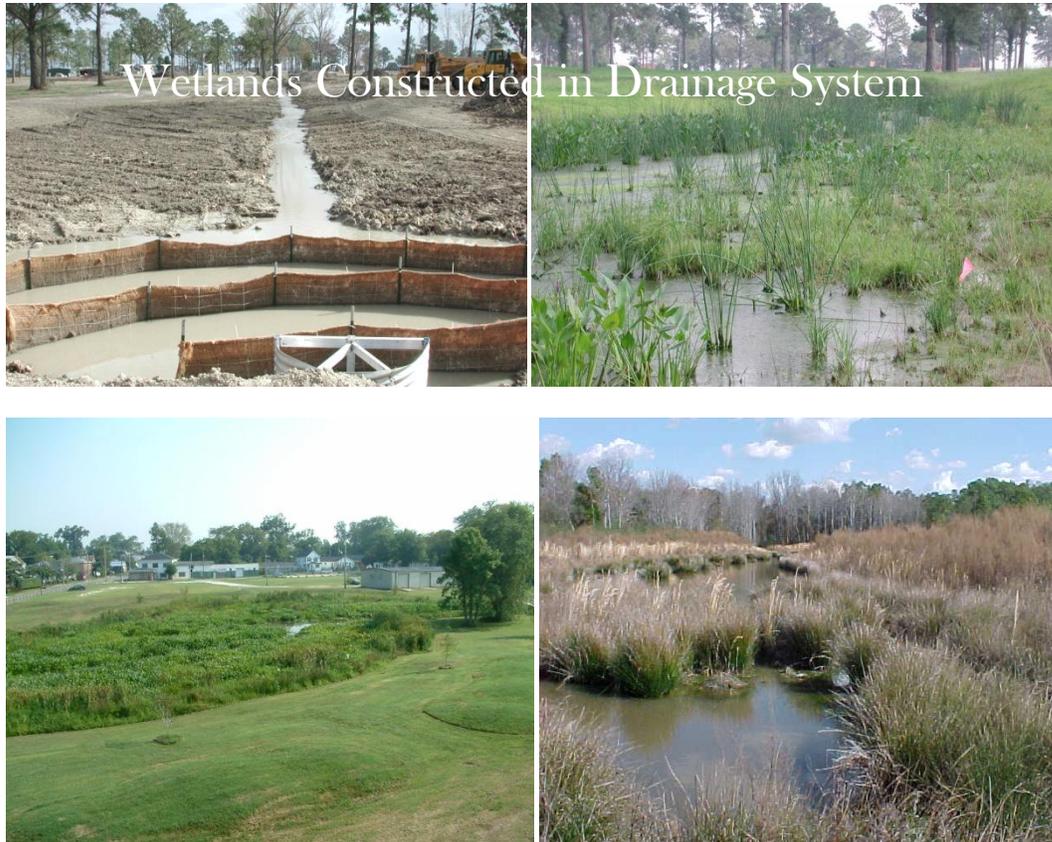
A wetland constructed within an existing drainage system to reduce the concentration of targeted pollutants (nitrogen, phosphorus, sediment) in drainage waters from runoff or subsurface flows before reaching creeks or streams in an effort to address watershed and regional water quality issues.

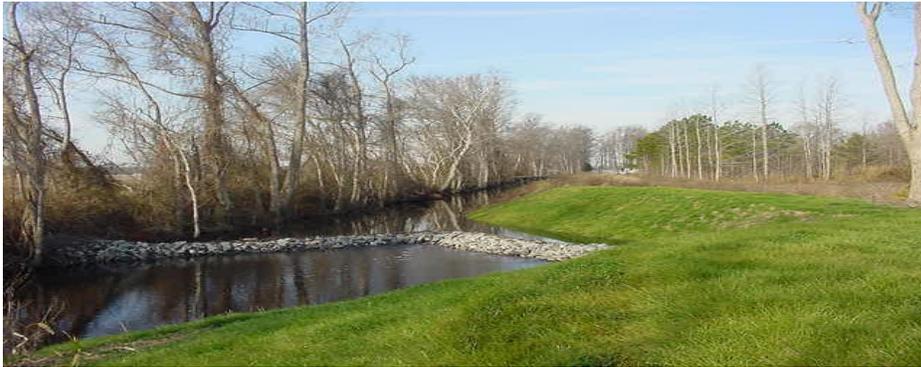
5. Wetland filters must be complimented with water control structures (usually Rock Weirs).

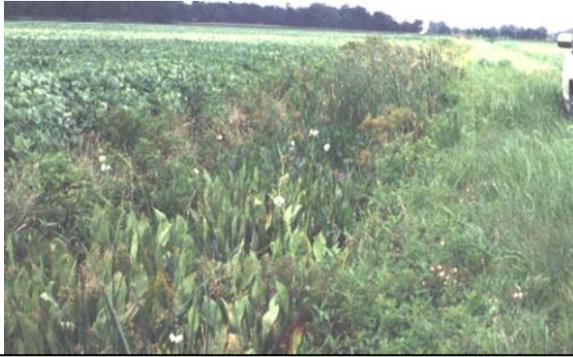
Figure 1. In-stream wetland reach of Tulls Creek project.

The first drainage alternative project was initiated in the Tull's creek watershed in Currituck County in 1995. The project involved a one mile reach of the main canal system draining approximately 80 ha of cropland. One reach of the canal (450 m) was managed in the traditional "free" drainage mode, a second reach was managed in the "controlled" drainage mode, and the third reach was planted with a variety of wetland plants (Fig 1) to provide a combination in-stream wetland/controlled drainage system. Approximately 4500 plants were planted in the wetland section. Based on visual observations made during September, 1996, over 90 percent of all species except cattail survived. Annual re-growth of wetland vegetation was excellent throughout the evaluation period (1997 – 1999). The outlet of each reach was instrumented to continuously measure outflow (Fig 2). Grab samples were collected monthly to evaluate treatment effects on water quality. In general, nitrogen concentrations were higher while phosphorus concentrations were lower with drainage control both with and without the addition of wetland plants. Total flow, phosphorus and sediment transport were significantly lower with both controlled drainage treatments. The addition of plants did not appear to provide an additional water quality benefit other than an improvement in water clarity over drainage control alone. Habitat benefits may have been enhanced by the plants; but, habitat benefits were not evaluated. This initial project demonstrated that it was possible to maintain wetland plants in drainage ditches without frequent mowing or adversely impacting the drainage performance of the ditch.

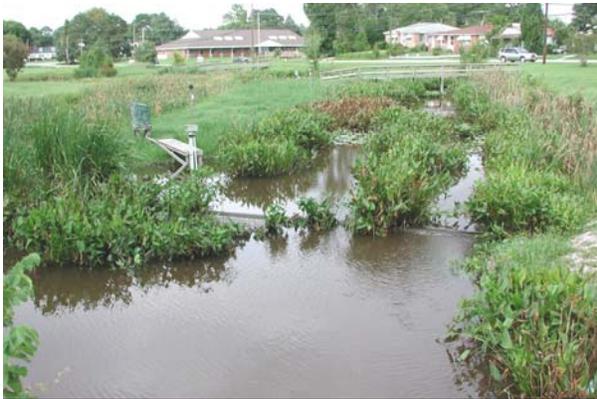
Figure 3. Constructed in-stream wetland, Edenton, N.C. construction was completed May,

such that the riparian floodplain was rarely functional. A 1 ha wetland was constructed in April-May, 1997. The wetland was built by excavating the existing hydraulically dysfunctional floodplain down to the stream base-flow level and raising the stream bottom (Fig 3). The soils found in the floodplain and used for the wetland substrate were variable, with some reduced and high in organic matter and others clayey in content. Islands were built in the interior to minimize transportation of cut/fill material and create a more sinuous flow path. A low head, wooden bulkhead was installed at the outlet to maintain water depths of 0.1m to 0.5m (6-18"). The wetland bottom was graded for a mixture of shallow and deeper pool areas. Native plants were used in the wetland and transplanted on a 1m x 1m spacing. The wetland intercepts drainage waters from approximately 240 hectares of surrounding watershed. One hundred and sixty hectares are attributed to agricultural and natural forested area, sixty ha to urban area, and twenty ha to intensive commercial areas. The resulting watershed/wetland area ratio is 100:1, which is less than half the minimum size typically recommended in the literature (Scheuler, 1992).

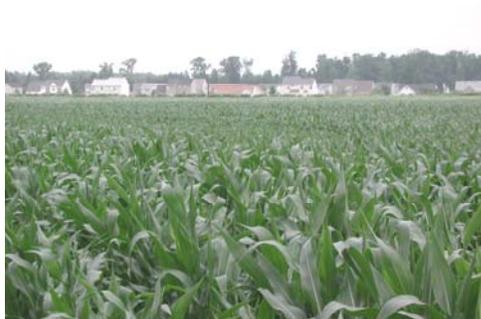
Figure 5. Residential development is rapidly displacing agricultural crop fields in Currituck County.

Currituck County is one of the fastest growing counties in North Carolina resulting largely from urban sprawl originating in Tidewater Virginia. The Guinea Mill watershed project (approximately 2,000 ha) was initiated in 1999 to address drainage and water quality issues arising from rapid urbanization of a predominately rural county (Fig 5). Over half the watershed is projected to be converted from farmland to residential by 2010. Drainage systems that were generally adequate for agricultural land uses are not adequate for residential development (Fig 6).

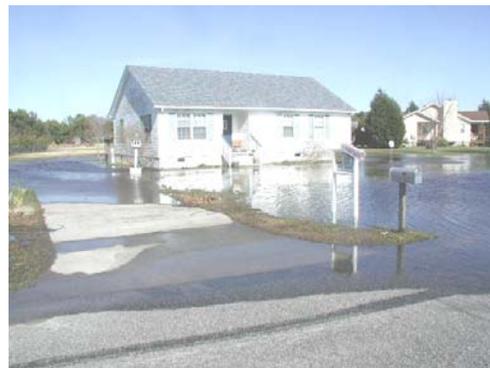
Figure 6. Agricultural drainage is often inadequate after urbanization.

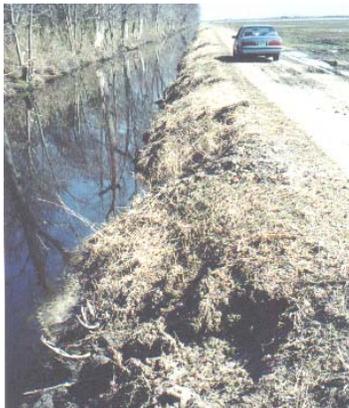
Figure 8. Upstream section of Guinea Mill with neither buffers or in-stream wetlands.

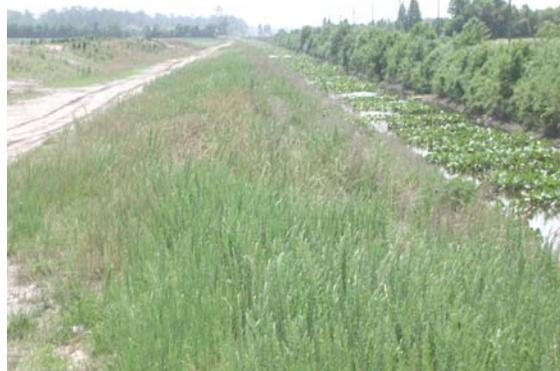
Figure 9. Lower section of Guinea Mill after installation of riparian buffer and instream wetland. Note path was moved away from canal bank.

Guinea Mill Canal dissects the watershed and runs the entire length of approximately 13 km (Fig 7). The fourteen kilometers of riparian buffers were established along the Guinea Mill Canal. Where farming use to occur next to the stream bank (Fig 8), buffers are established with vegetation maintained 0.3 to 1 m high (Fig 9). In-stream constructed wetlands (Fig 9) were installed on 3.4 ha within the Guinea Mill Canal. In the wetland section, the canal was widened from 10 to 20 m. The widened channel section increased the cross sectional area of the channel to offset the increased flow resistance resulting from the wetland plants. Two in-stream wetland cells were constructed one approximately 2 km and the second about 1 km in length. The wetland cells were planted with a variety of wetland plants on a 1 m by 1 m spacing.

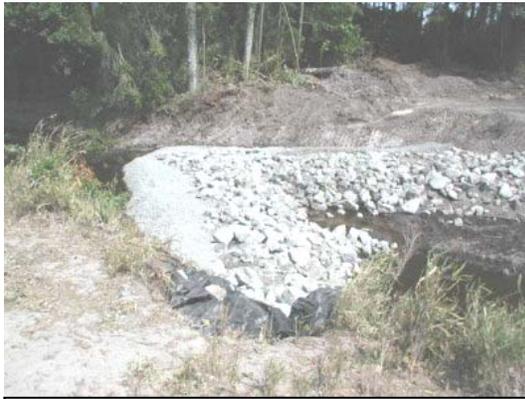
Figure 10. Rock weir soon after installation.

A rock weir water control structure was installed to enhance hydrologic function at low flows. The rock weir (1 m high by 1.2 m top width by 21 m length) was located just downstream of a 15 ha hardwood swamp (Fig 10). The hydrology of the swamp had been significantly altered by channelization of Guinea Mill Canal. The rock weir raised the base flow elevation by

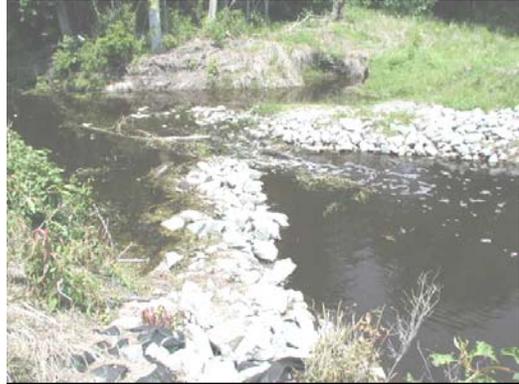
Figure 11. Rock weir raises upstream water level at base flow enhancing hydrologic function of upstream swamp.

approximately 1 m, restoring some hydrologic function to the riparian swamp (Fig 11). In addition, scour pools formed downstream of the rock weirs which enhanced aquatic habitat. As in previous examples, the channel was widened in the vicinity of the rock weirs to offset the reduction in flow depth resulting from the weir. Annual inspections of all conservation easements are made by the Advisory Board and the Currituck SWCD Board with their respective reports submitted to the County commissioners.

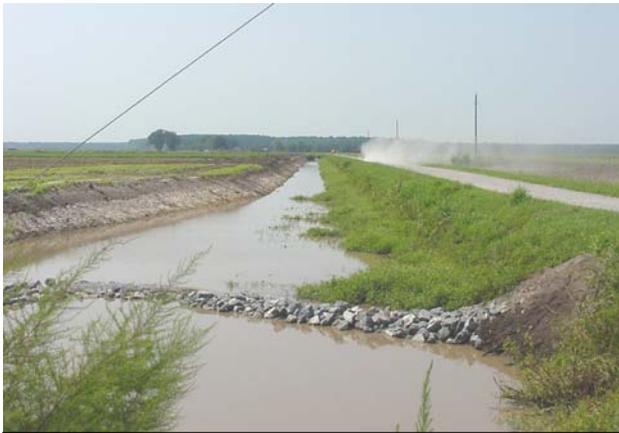
Figure 12. Section of Shepard Ditch showing bank shaping, wetland ledge and rock weir soon after installation.

This project involved development of a conceptual water management plan for the refuge that balanced the water management needs of the refuge with the drainage and water quality needs of the downstream landowners and citizens. Debris was cleared and snagged in the upper Pasquotank River which is the outlet for both the 158 and Sheppard Ditch canals. Both canals were excavated to stabilize stream banks. The ditch bottoms were excavated to create a ledge for establishment of 2.6 acres of in stream constructed wetlands (Figs 12 and 13).

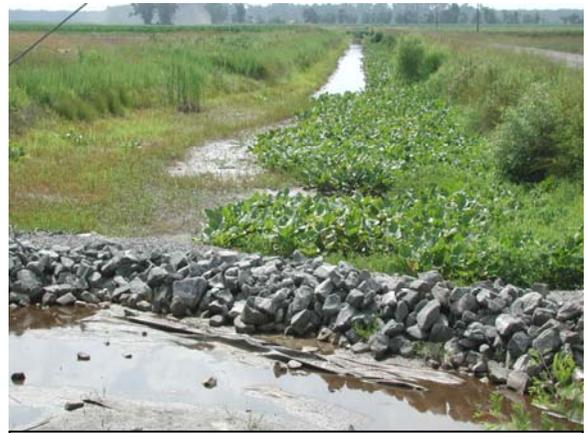
Figure 13. Section of Shepard Ditch during dry period after establishment of wetland plants on constructed ledge (right bank).

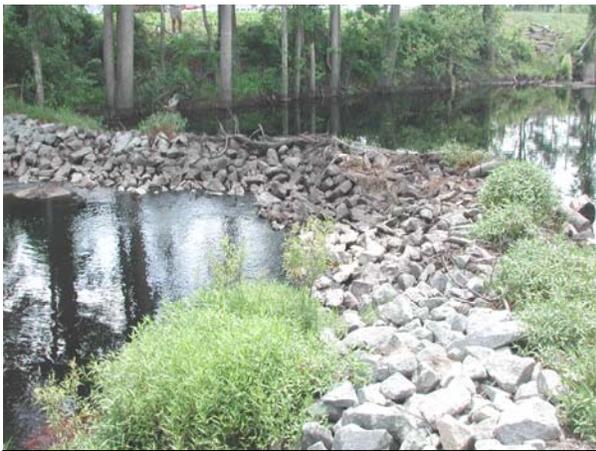
Figure 14. One of five rock weirs installed to elevate the water level at base flow and enhance hydrologic function.

Five associated rock weir water control structures (Figs 14 and 15) were installed to enhance base flow hydrology and ecological function. At the rock weirs, the channel is widened to maintain the same cross sectional area as existed prior to the project so that the channel capacity will not be reduced at high flows. Vegetative buffers were established along 4.2 km of the 158 Canal and 3.6 m on Sheppard Ditch. Annual inspections are made by the Advisory Board and the Pasquotank SWCD Board with their respective reports submitted to the County commissioners.

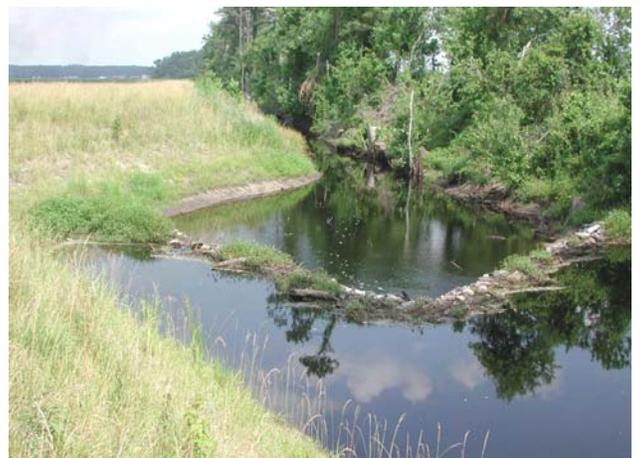
Figure 15. Vegetative buffers were established along ditch banks and the channel was widened to maintain capacity at the rock structures.

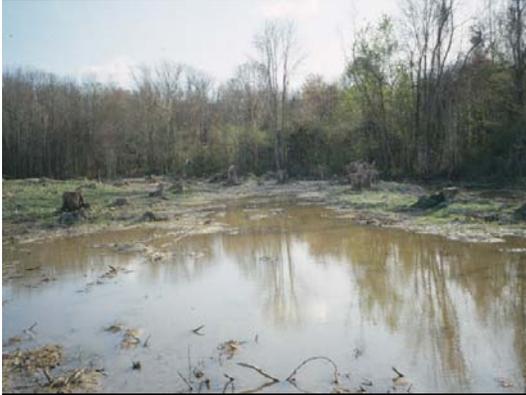
Figure 16. Restored swamp and floodplain reach of Edenton airport project.

The Edenton Airport and Industrial Park restoration and enhancement project in Chowan County was initiated in 2000. As part of the construction and development of the Edenton Army Base in the 1930's, the lower stream reach of the watershed was channelized with the spoil deposited in the adjacent floodplain and a short circuit cutoff constructed that shortened the flow path of drainage water to the Albemarle Sound by more than a kilometer. This project involved three hydrologic enhancements. The first involved restoration of stream and riparian floodplain functions in the lower stream segment. Spoil piles were removed to restore some hydrologic functions to the floodplain (Fig 16). Re-growth maples were replaced with cypress and mixed bottomland hardwood species. At several locations, the straightened, channelized stream was re-routed back through its original floodplain (Fig 17).

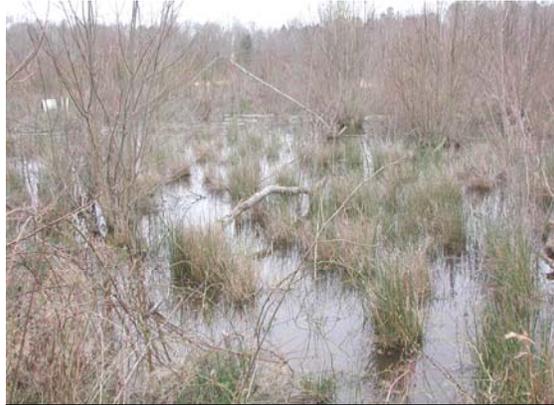
Figure 17. View of lower floodplain after third growing season.

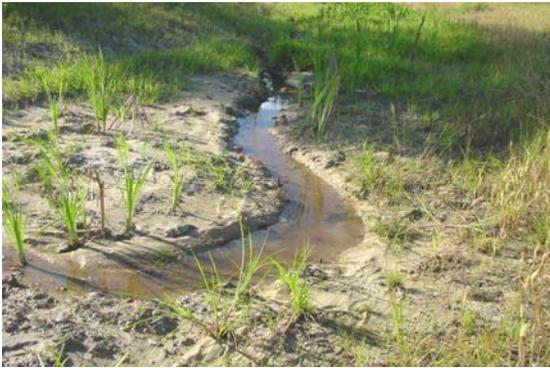
Figure 18. Constructed stream and floodplain of small headwater stream.

The second hydrologic enhancement involved construction of a 300 m reach of stream and riparian floodplain. Final design consisted of an 250 m stream/wetland valley with floodplain width varying from 7 to 10 m. The stream was designed to meander within the wetland valley (Fig 18). The stream/wetland system was designed to be from 0.5 to 1.5 below original grade. Lastly a series of 3 storm water wetlands were constructed between the constructed and restored stream reaches (Fig 19).

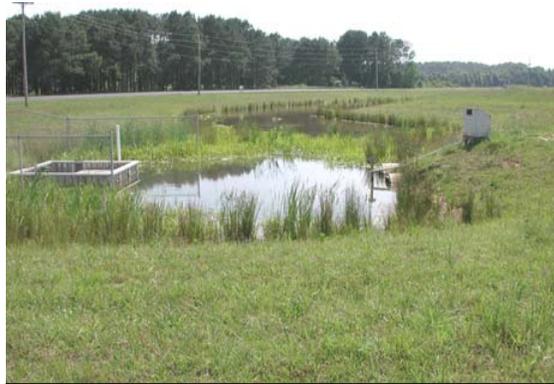
Figure 19. Constructed stormwater wetland in series in drainage system.

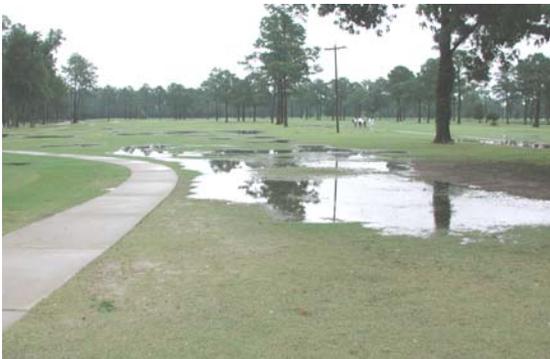
Figure 20. Poor drainage and ponding at Chowan Golf Club prior to project.

An innovative approach was initiated in 2003 to manage poor drainage and stormwater (Fig 20) at the Chowan Golf Course. Existing drainage ditches (Fig 21) were redesigned utilizing natural channel design concepts along with HEC-RAS hydrologic analysis and interconnected to a network of twelve constructed stormwater wetlands (Fig 22 and 23) ranging in size from 0.1 to 2 ha. On this project, the ratio of watershed area to wetland area is 10:1. All stormwater conveyance channels and wetlands are protected by a permanent conservation easement under the control of the County Commissioners.

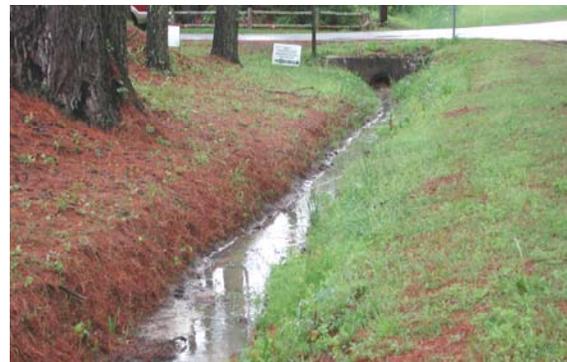
Figure 21. Typical drainage ditch on Chowan Golf course prior to stream project.

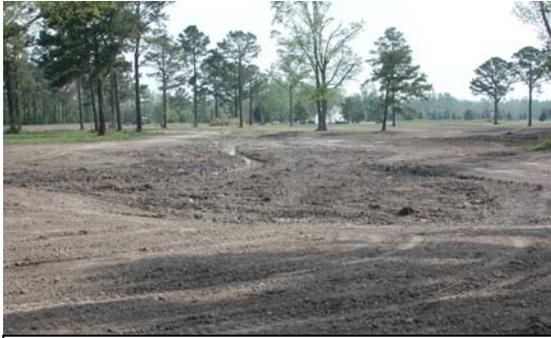
Figure 22. Constructed stream channel with riparian floodplain after construction.

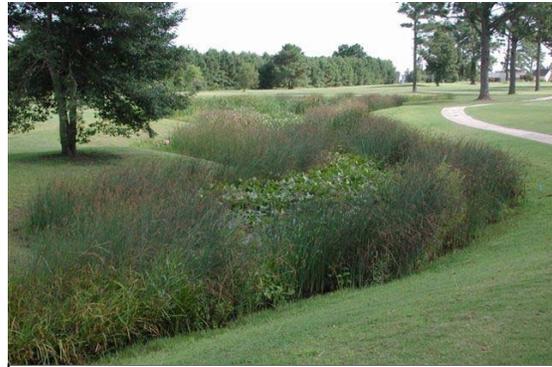
Figure 23. Constructed stream and wetland one month after planting.

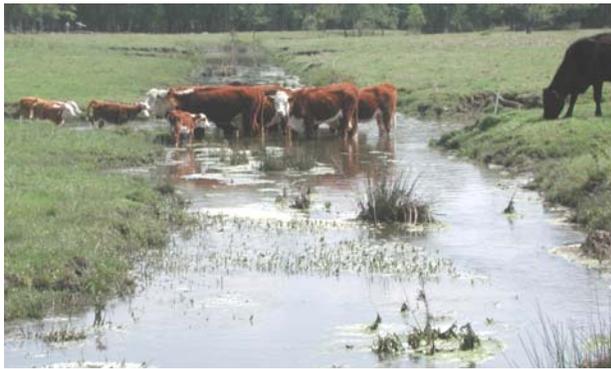
Figure 24. Cattle in Core Creek tributary stream prior to restoration.

The Core Creek project consisted of relocation of an unnamed channelized stream within the Core Creek watershed that had been significantly impacted by cattle access (Fig 24). The degraded stream was a G5 class (Rosgen classification system) channelized stream with severe bank erosion and degraded water quality. The new channel was designed using a combination of

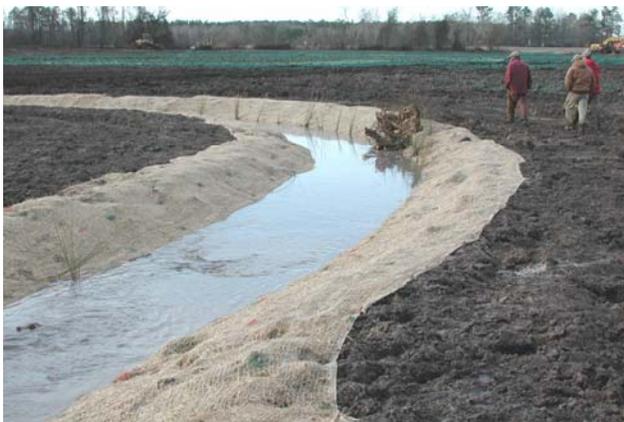
Figure 26. Core Creek relocated stream just after construction.

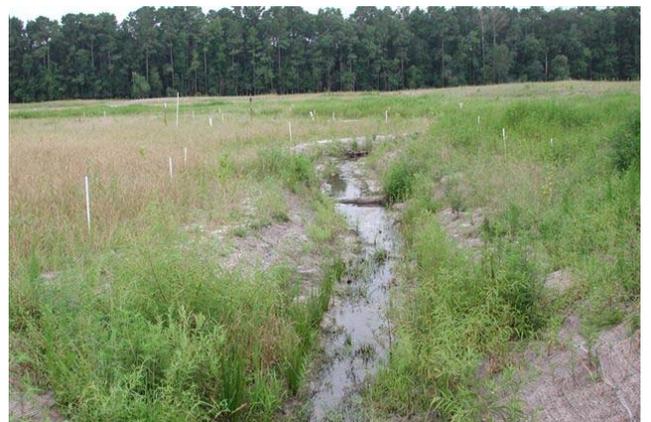
Figure 27. Core Creek relocated stream one year after construction.

The constructed stream consisted of a uniform dimensional section, meandering pattern, and 0.1% slope (Fig 25). A 30 to 40 m wide stream valley was constructed by stockpiling 150 mm of topsoil then removing 0.5 to 0.6 m of subsoil. The topsoil was then redistributed across the valley followed by construction of a 3.5 m (top width) by 0.5 m deep E5 channel with an average sinuosity of 1.3 (Fig 26). Log vanes were used to hold grade and root wads to armor banks. Flow hydraulics and design structures controlled riffle/pool formation (Fig 27).
