NCDA&CS - North Carolina Forest Service

Stream Restoration Post-Implementation Annual Monitoring Report: Year 3 - 2011

For the N.C. Clean Water Management Trust Fund (CWMTF)
Project #2004A-411:
“Rendezvous Mountain Purlear Creek Stream Restoration”

January 2012

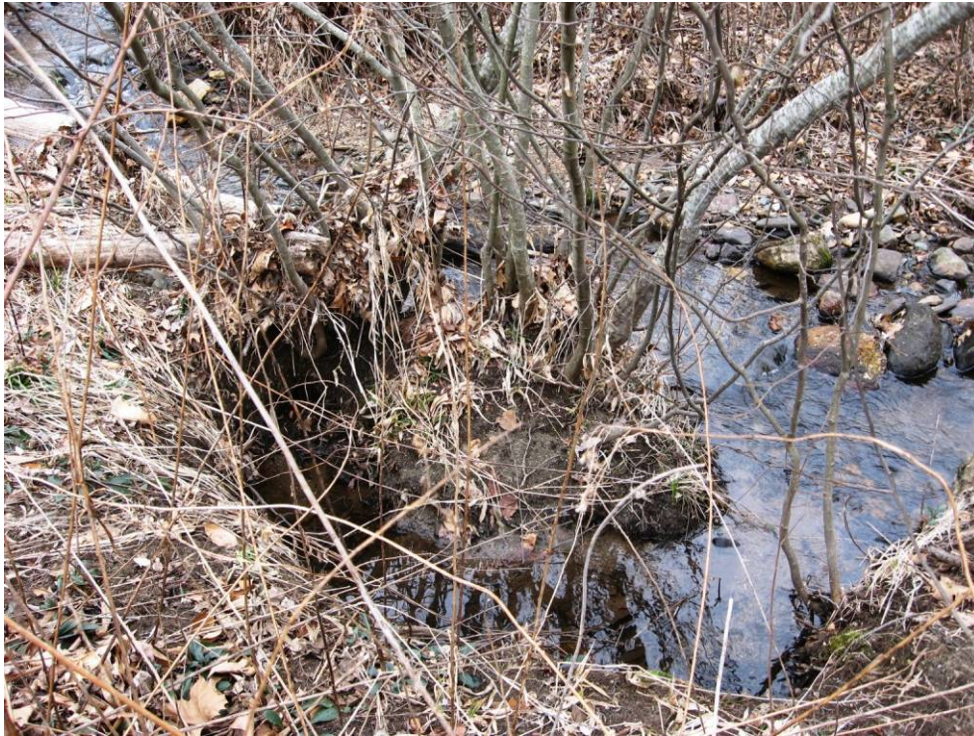
Photo at left:
February 22, 2011.
The stream has
washed around this
rootwad of alder
shrubs along its right
bank.

A stream channel survey will be conducted in early 2012 by NCSU personnel. Observations during 2011 indicated two small areas of stream bank instability along the upper reach of Phase-2, in a location where the old stream channel was retained and in-stream structure was added as part of the restoration. The photos below illustrate these two small areas of instability. Based on our follow-up observation in December 2011, these areas have not gotten any worse. They will be monitored and if needed, hand-work repairs will be made.

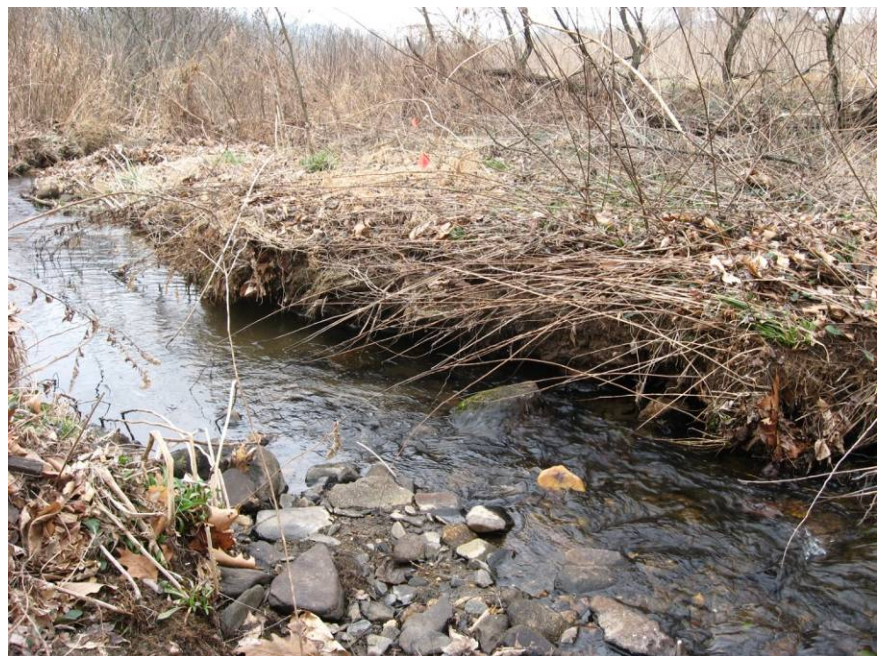
Photo at right: February 22, 2011.
This short segment of right bank
has been partially undercut.

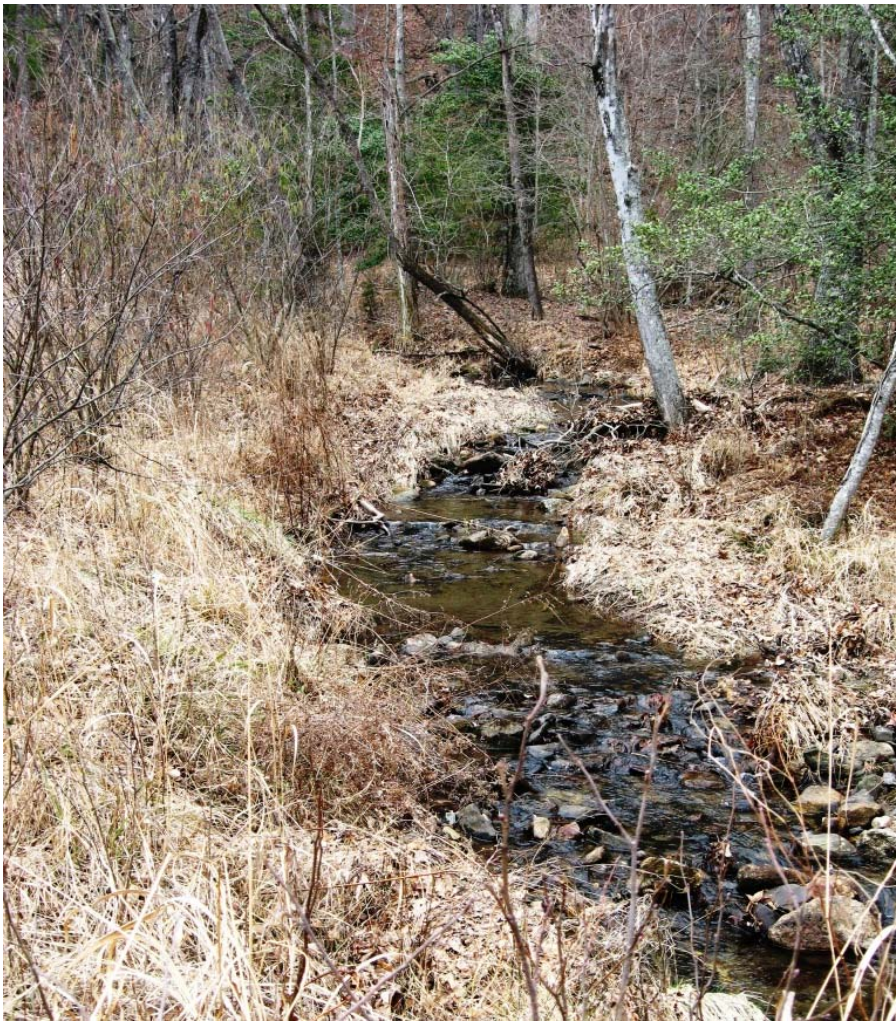
Photo at left: February 22, 2011. This upper reach of Purlear Creek that was restored in Phase-2 remains stable. The riffles and log vanes that were installed remain intact and functioning. Transplanted alder shrubs (left) have acclimated and put on abundant new stem growth.

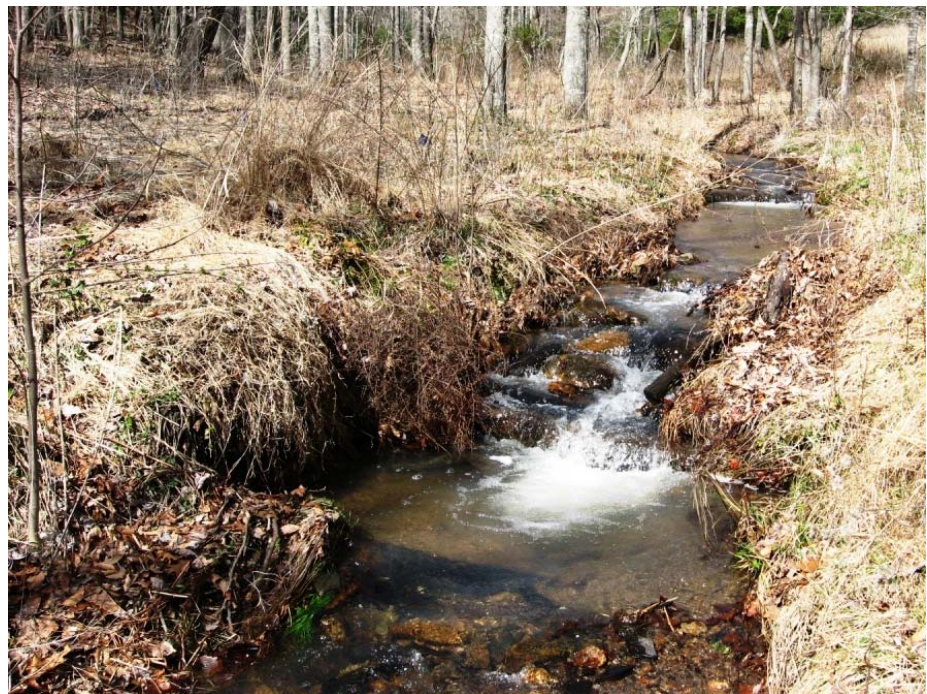
Photo at right: March 7, 2011. This is a view of the unnamed tributary to Purlear Creek, restored during Phase-1 and 2. Note the abundant leaf litter deposited along both stream banks, indicating high water events. Structures remain intact and functioning. Some of the pools are partially filled, as legacy sediment is mobilized downstream through the restored system.

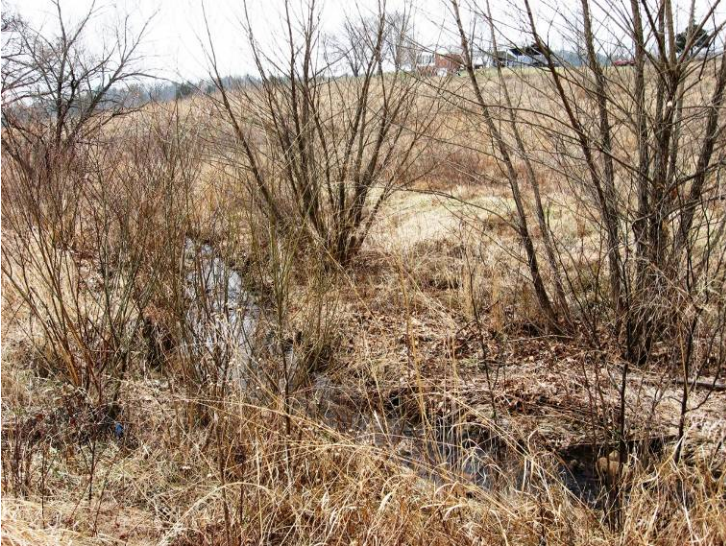
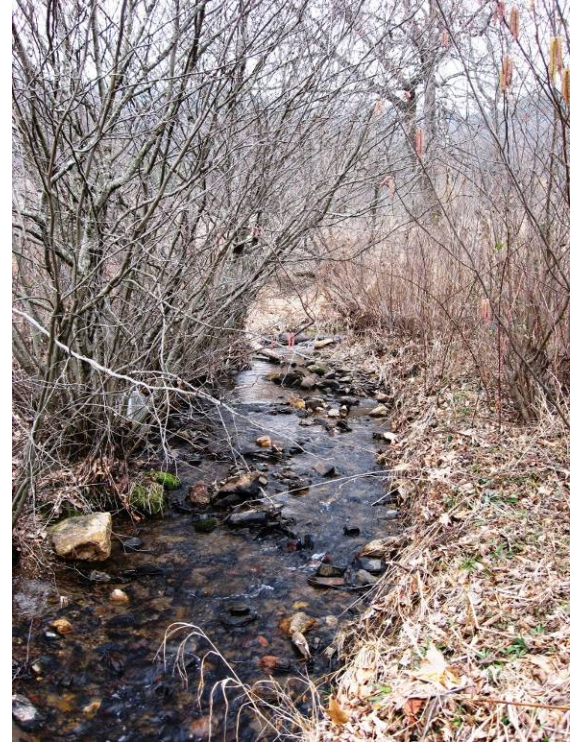
Both photos taken along Phase-2: February 22, 2011. Photo above shows clumps of willow on opposite side of stream, and transplanted alder shrubs on near side. Photo at right shows a short segment which is nearly completely shaded-over by alder during the growing season.

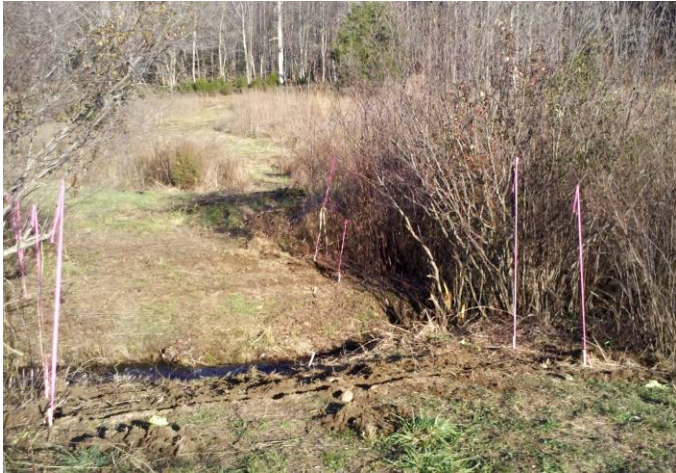
Crossing location prior to bridgemat installation. Vegetation disturbance was kept to a minimum. Soil erosion was mitigated by installation of silt fence.

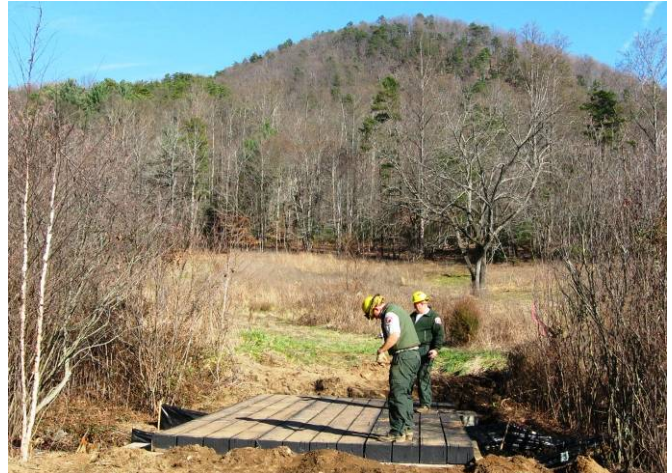
Bridgemat crossing installed. The State Forest property on the opposite side of the stream crossing is now accessible.

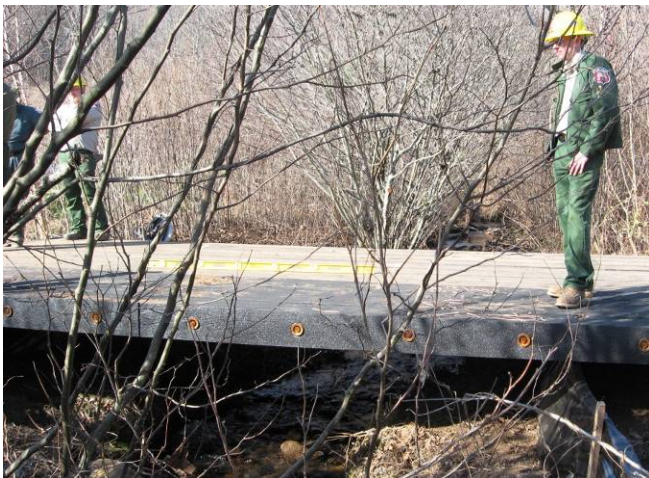
A side view of the installed bridgemat crossing, looking upstream.

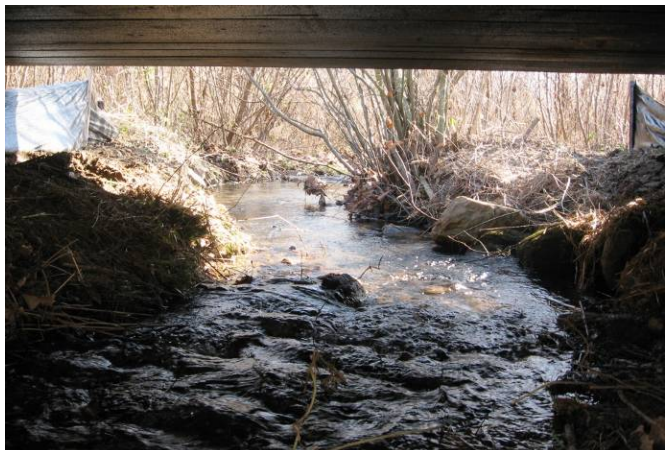
View from underneath the crossing, looking downstream.

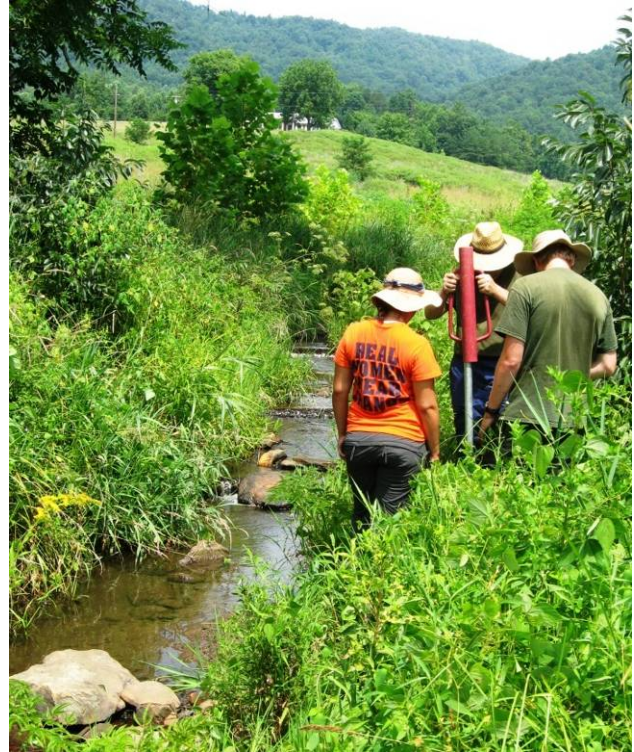
Photo at right: August 3, 2011.

A group of faculty and staff from UNC-Charlotte install a shallow piezometer to evaluate the groundwater level along a portion of Phase-3.

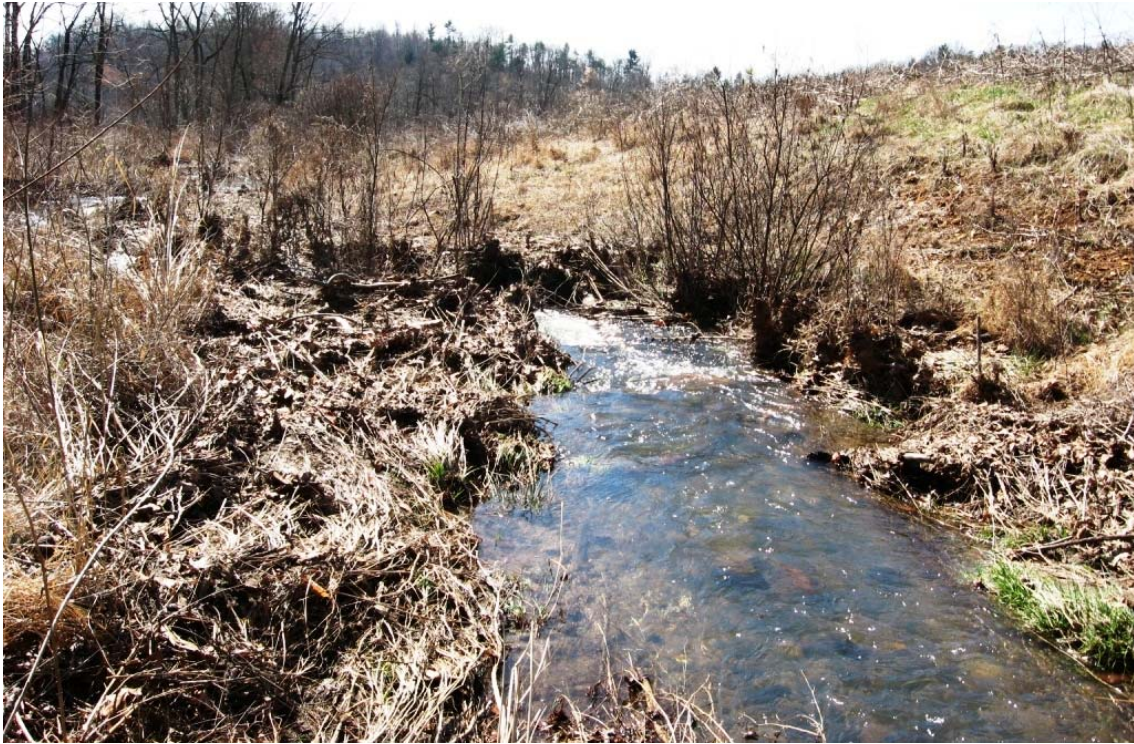
Both photos from March 7, 2011. Top photo is a view of Phase-2 looking downstream. The bottom photo shows a view of Phase-3 looking upstream. The automated rain gauge on the State Forest recorded 5.5 inches of cumulative rainfall over the prior 11 day period. The stream's structure has held up very well in 2011 in spite of the abundant annual precipitation recorded at the site (most since the project was completed). Our observations of floodplain sediment deposition, matted vegetation, and wrack piles indicate effective connectivity between the stream and its floodplain during high water events.
