Success Stories & Accomplishments
N.C. Forest Service, Nonpoint Source & Water Quality programs

BMP Manual & Field Guide

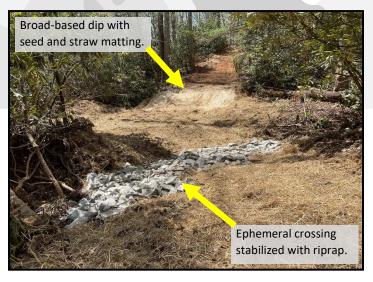
A new ford crossing installed to replace a crushed culvert. Surplus geotextile netting from the nursery was used at the crossing approach way and underlayment for the stone.
