**An assessment of Forestry Best Management Practices in North Carolina, 2018-2020**

**Prepared by:  
Water Resources Branch  
North Carolina Forest Service  
North Carolina Department of Agriculture and Consumer Services  
August 2022**

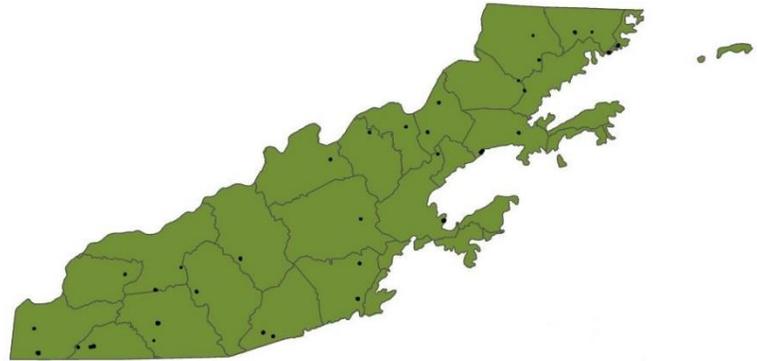
### 4.2.1 Mountains

explained by the type of skid trails (bladed), lack of cover and poor locations or excessive number of skid trails. Bladed trails are often necessary to safely traverse steep terrain with wheeled logging equipment. However, these trails are known to be more prone to erosion and subsequently present more challenges for erosion control BMPs when compared to overland skid trails. It is our observation that slash on skid trails is less often placed and driven over when compared to other regions. Additionally, some tracts also had seemingly unnecessary trails, or trails that were too close together, which resulted in more skid trails per harvest area compared to other regions. Emphasis on minimizing the extent of skid trails, locating them in the least impactful areas and installing measures to slow and disperse runoff should be the focus of outreach and education in this region.

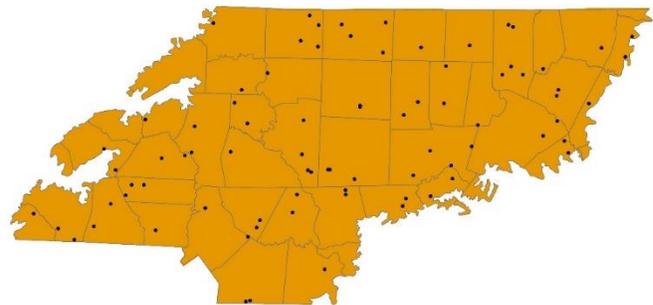
There were 80 survey units and 13,717 BMP opportunities recorded in the Piedmont ecoregion. Roughly 84% of BMP observations were categorized as properly implemented and about 3% of BMP observations were associated with a water quality risk. Several BMP categories had proper implementation scores above 85%. The skid trail (74%) and road access (79%) categories scored lowest of the categories with more than 30 observations. The low proper implementation score of the skid trail and haul roads can be partially explained by lack of erosion control measures used,

poor or excessive skid trail locations and lack of BMP improvements or maintenance for legacy skid trails and roads. It was our observation that operators reopen historic/legacy roads and trails without applying necessary erosion control measures or other upgrades to minimize erosion potential at locations away from streams. However, near streams we observed a higher usage rate of BMPs for erosion control. The lack of erosion control measures away from the stream can result in a water quality risk if runoff is allowed to concentrate and flow

downhill uncontrolled. Emphasis on keeping roads and trails away from legacy gullies and ephemeral streams, and implementing BMPs in these areas should be the focus of outreach and education in this region.

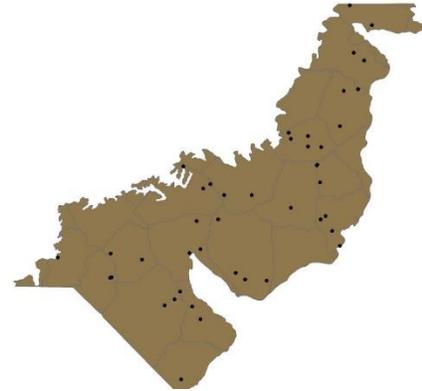
Approximately 89% of BMP observations were categorized as properly implemented. Roughly 1% of BMP observations were associated with a water quality risk. All but two BMP categories had proper implementation scores above 85%. The rehabilitation of the project site (81%) category scored lowest of the categories with more than 30 observations.

The low proper implementation score of this category can be partially explained by debris observed in channels at stream and ditch crossings. In many cases, water could percolate through blockages and there were no observations of water backing up onto an adjacent landowner's property. Fine sand and silt soils common in this region can be problematic when used as a road base. A lack of road base compaction lends these roads susceptible to scour and increased erosion potential. Emphasis on using curb logs at bridgemat crossings to reduce debris falling in channels, removal of excessive logging debris from waterways, and identifying opportunities to improve road base structure should be the focus of outreach and education in this region.

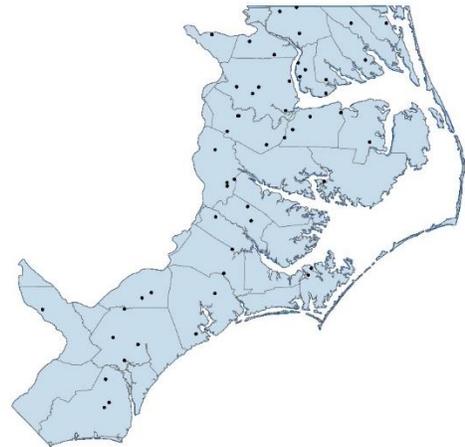
There were 56 survey units and 4,895 BMP opportunities that we recorded in the MACP ecoregion. Roughly 87% of our BMP observations were categorized as properly implemented BMPs. Most BMP categories had scores above 85%. The site preparation (69%) and logging systems (75%) categories scored lowest of the categories with more than 30 observations. Risks to water quality were only associated with about 2% of BMP observations. Only three tracts assessed had mechanical site preparation. Our observations of those tracts revealed some water ponding on areas of the tract where there were no gaps within bed rows and there were large contiguous areas of bare soil. The slight deficiencies in logging system selection BMPs were associated with rutting. Rutting can be avoided or reduced by ceasing operations when machine travel creates deep rutting, deploying special logging tactics (such as 'shovel trails'), or low ground pressure equipment (such as tracks or dual tires). Emphasis on identifying wet ground areas, and strategic planning of when and how to access them should be the focus of outreach and education for harvesting in this region. Emphasis on when and where to leave gaps in bedding rows that prevent water impounding, while minimizing contiguous bare soil areas near waterways should be the focus of outreach and education for mechanical site preparation in this region.

Rutting can be avoided or reduced by ceasing operations when machine travel creates deep rutting, deploying special logging tactics (such as 'shovel trails'), or low ground pressure equipment (such as tracks or dual tires). Emphasis on identifying wet ground areas, and strategic planning of when and how to access them should be the focus of outreach and education for harvesting in this region. Emphasis on when and where to leave gaps in bedding rows that prevent water impounding, while minimizing contiguous bare soil areas near waterways should be the focus of outreach and education for mechanical site preparation in this region.
