Stream Restoration Post-Implementation Annual Monitoring Report

Year 5: 2016

Project #10-0493:

“DuPont State Recreational Forest Lake Julia Outfall Stream
Restoration”

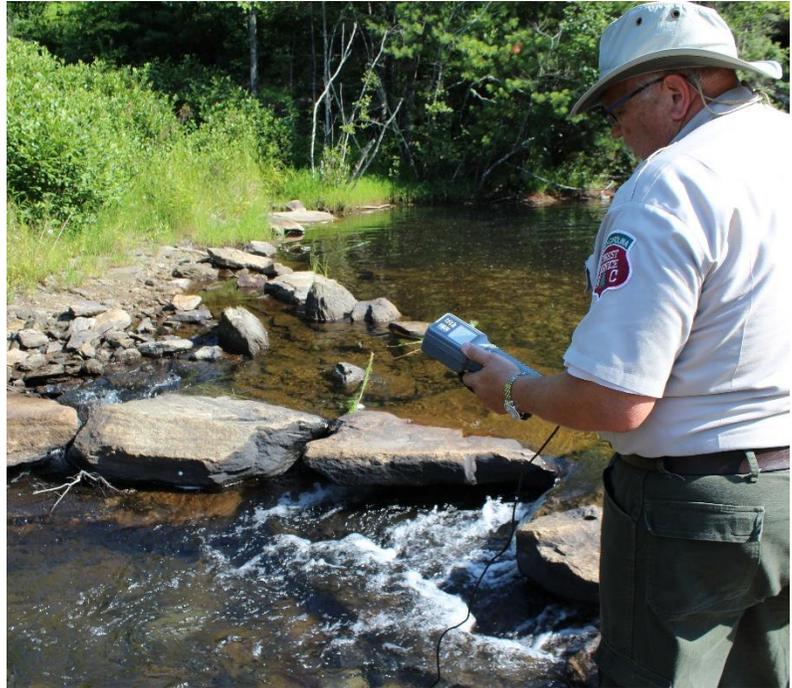
In late June 2016, the NCFS Forest Hydrologist conducted spot-sampling of the restored reach to assess water temperature, conductivity, and dissolved oxygen, taking samples in both the riffles and pools at various depths. The findings indicated complete uniformity in both the temperature and dissolved oxygen readings, with little variability in conductivity. This indicated that water in both the pools and riffles were well mixed in late June. Water quality parameters were less ideal than the previous measure in early May of 2015. Low stream flow due to a recent onset of drought conditions was the suspected cause of the June 2016 water quality conditions. The surrounding watershed had received less than 1-inch of rainfall over the past month prior to sampling.

The upper strata heat of Lake Julia reservoir and shallow flows over bedrock into the restoration project were also suspected contributors to the June 2016 water quality measures. Temperature was 14.4 °F greater and dissolved oxygen 3.9 mg/L lower than May 2015 measures. Conductivity was again low (22.7 µs/cm), but expected given weather conditions. Water quality parameters were recorded as follows:

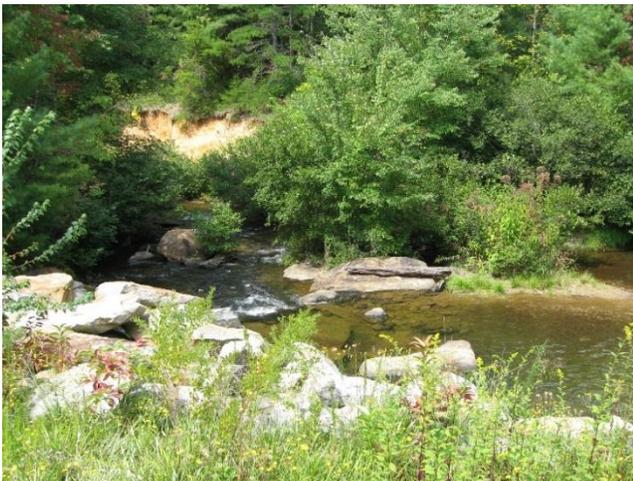
Stream channel near the forest access road bridge in May 2009 (left). Soil loss was occurring from the exposed vertical soil embankment on the right stream bank (legacy channel) in Sept. 2009 (right).

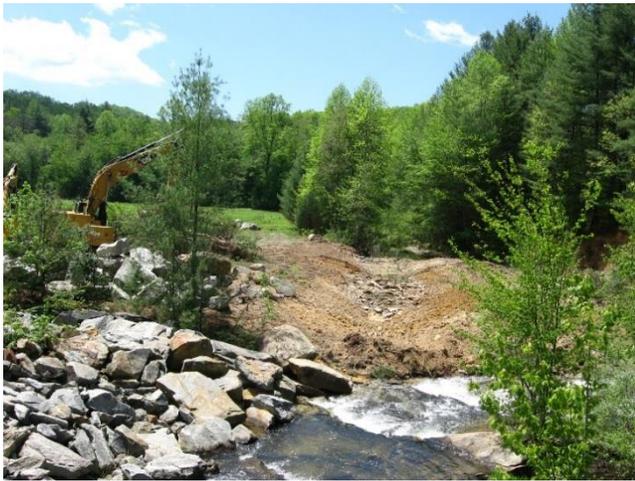
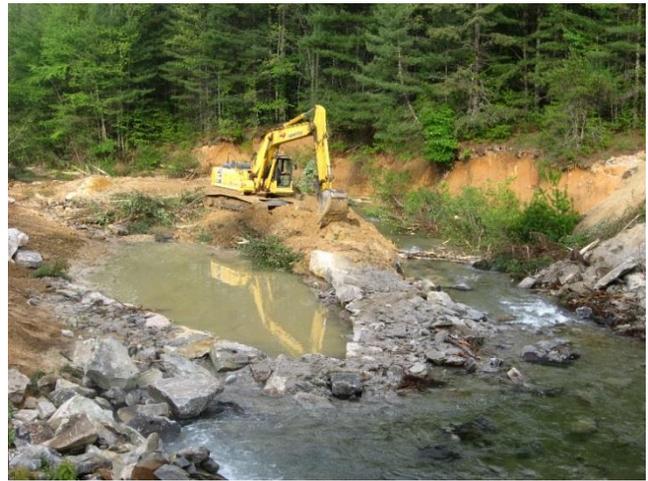
View from the forest access road bridge during stream reconstruction in May 2011.

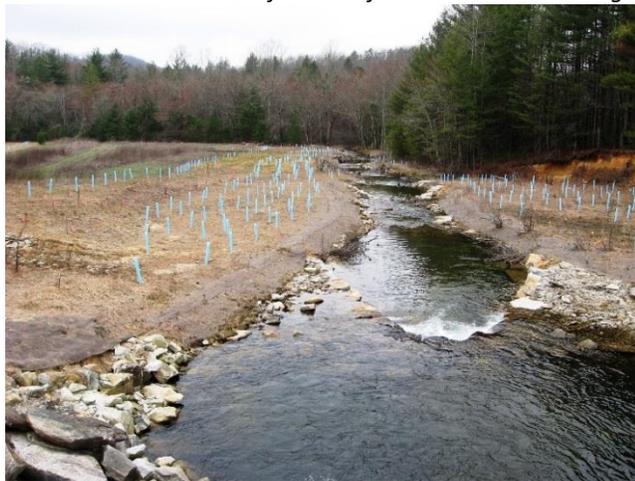
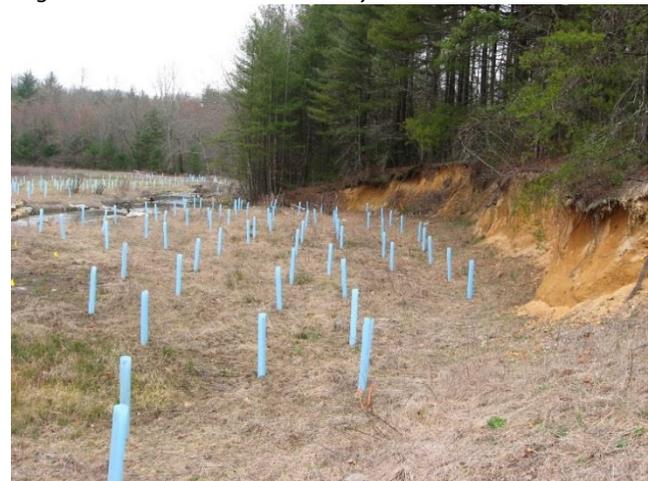
View from the forest access road bridge (left) and from the right bank (right) ~1 year after stream reconstruction (March 2012).

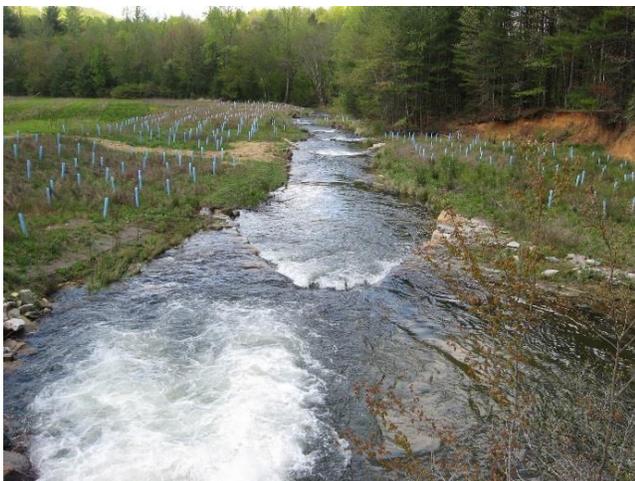
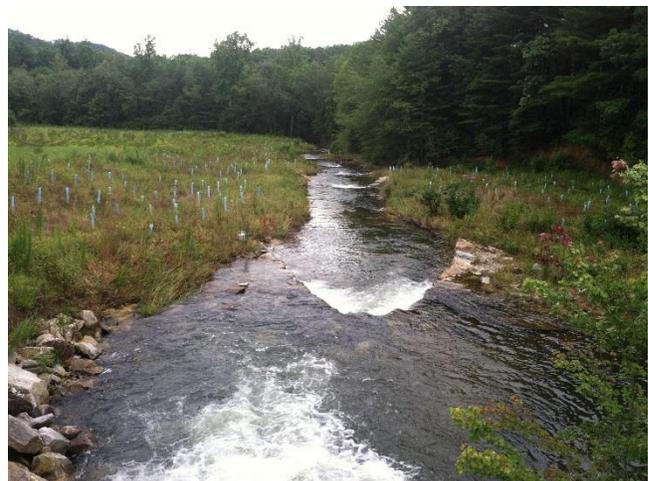
View from the forest access road bridge ~2 years after stream reconstruction (May 2013 [left] and Aug. 2013 [right]).

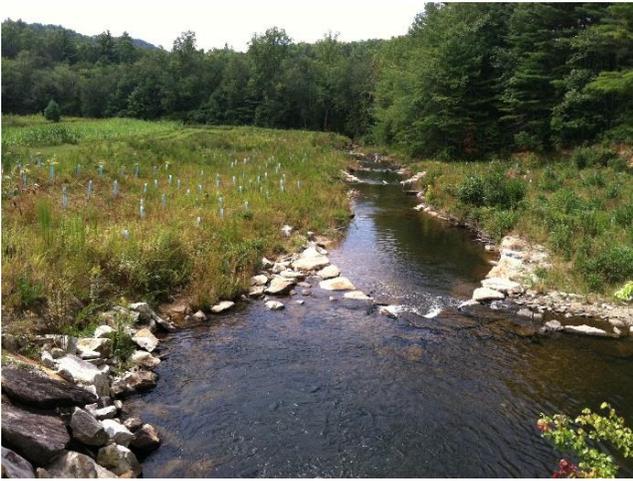
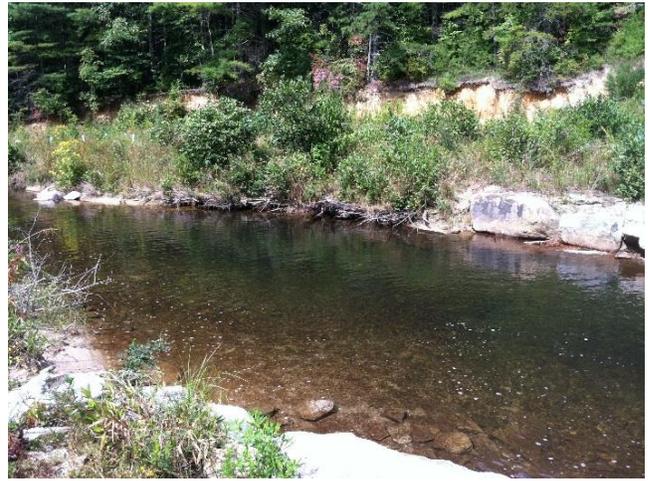
View from the forest access road bridge (left) and from the left stream bank (right) ~3 years after stream reconstruction (Sept. 2014).

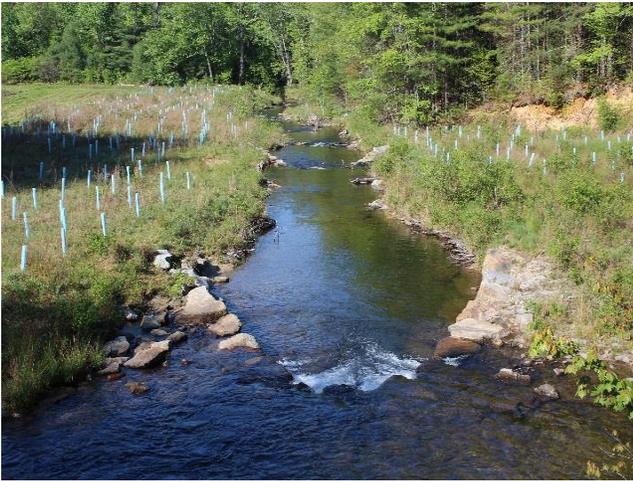
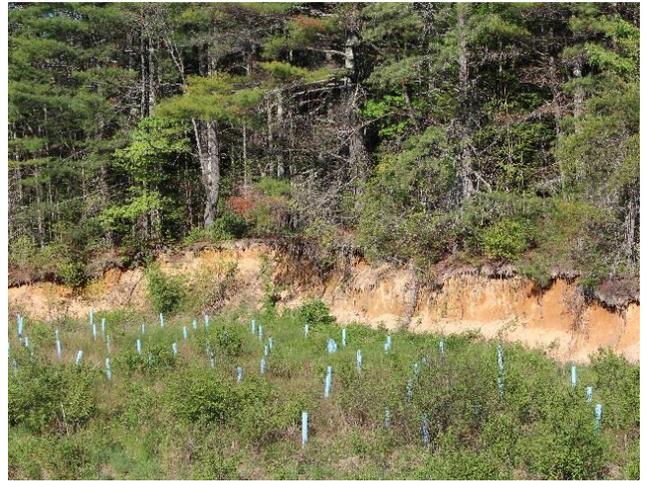
View from the forest access road bridge (left) and from the left stream bank (right) ~4 years after stream reconstruction (May 2015).

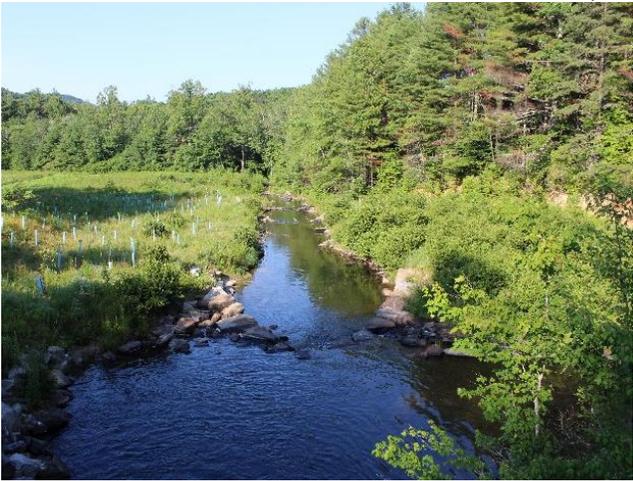
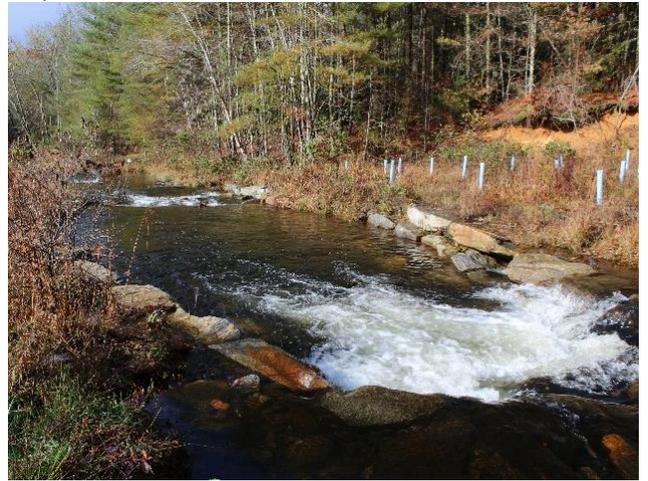
View from the forest access road bridge (left) and from the left stream bank (right) ~5 years after stream reconstruction (June 2016 [left] and Nov. 2015 [right]).
